Chaojun Ouyang · Wei Zhao · Qiang Xu · Dalei Peng · Weile Li · Dongpo Wang · Shu Zhou · Shunwei Hou

Failure mechanisms and characteristics of the 2016 catastrophic rockslide at Su village, Lishui, China

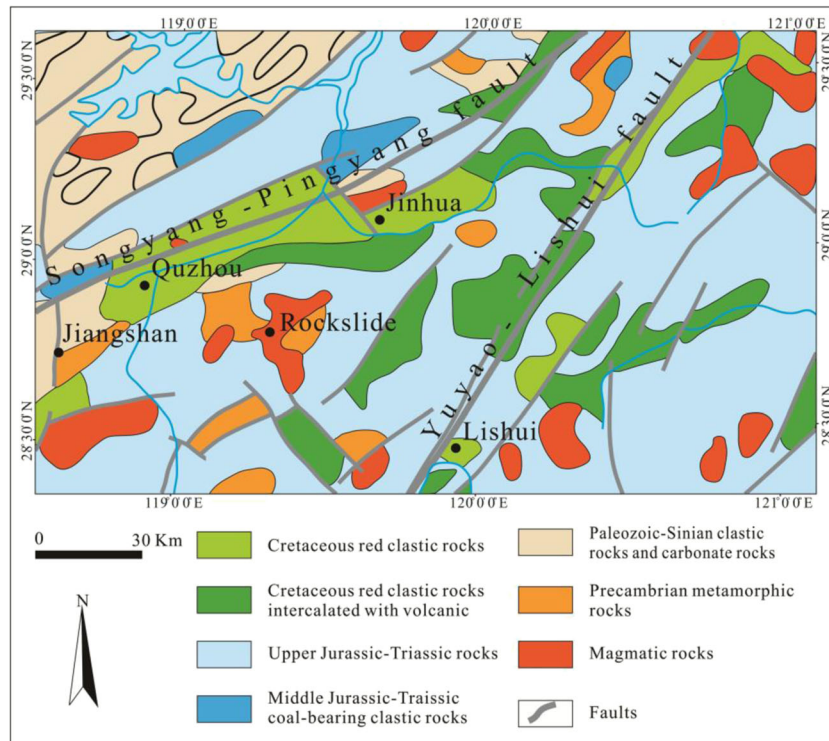
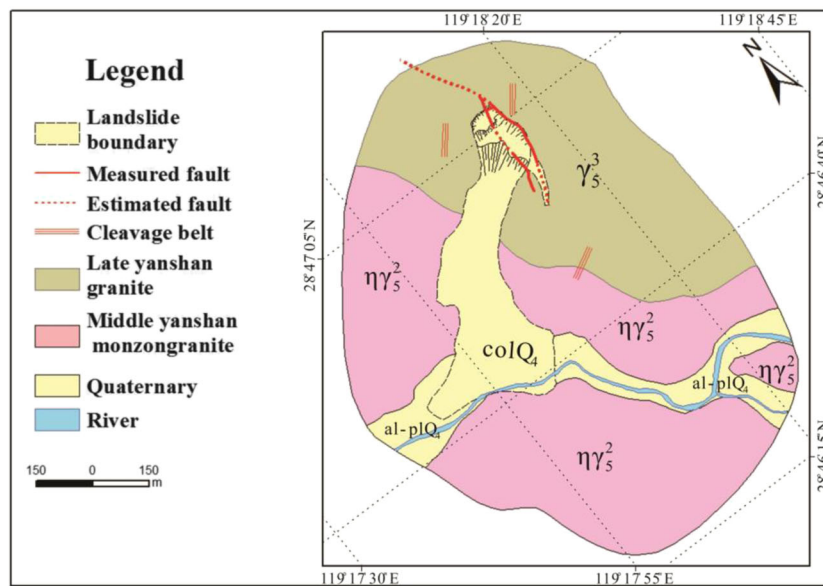
Fig. 2 Geological map of the **a** study area (modified from Ma et al. 2015) and **b** slide site

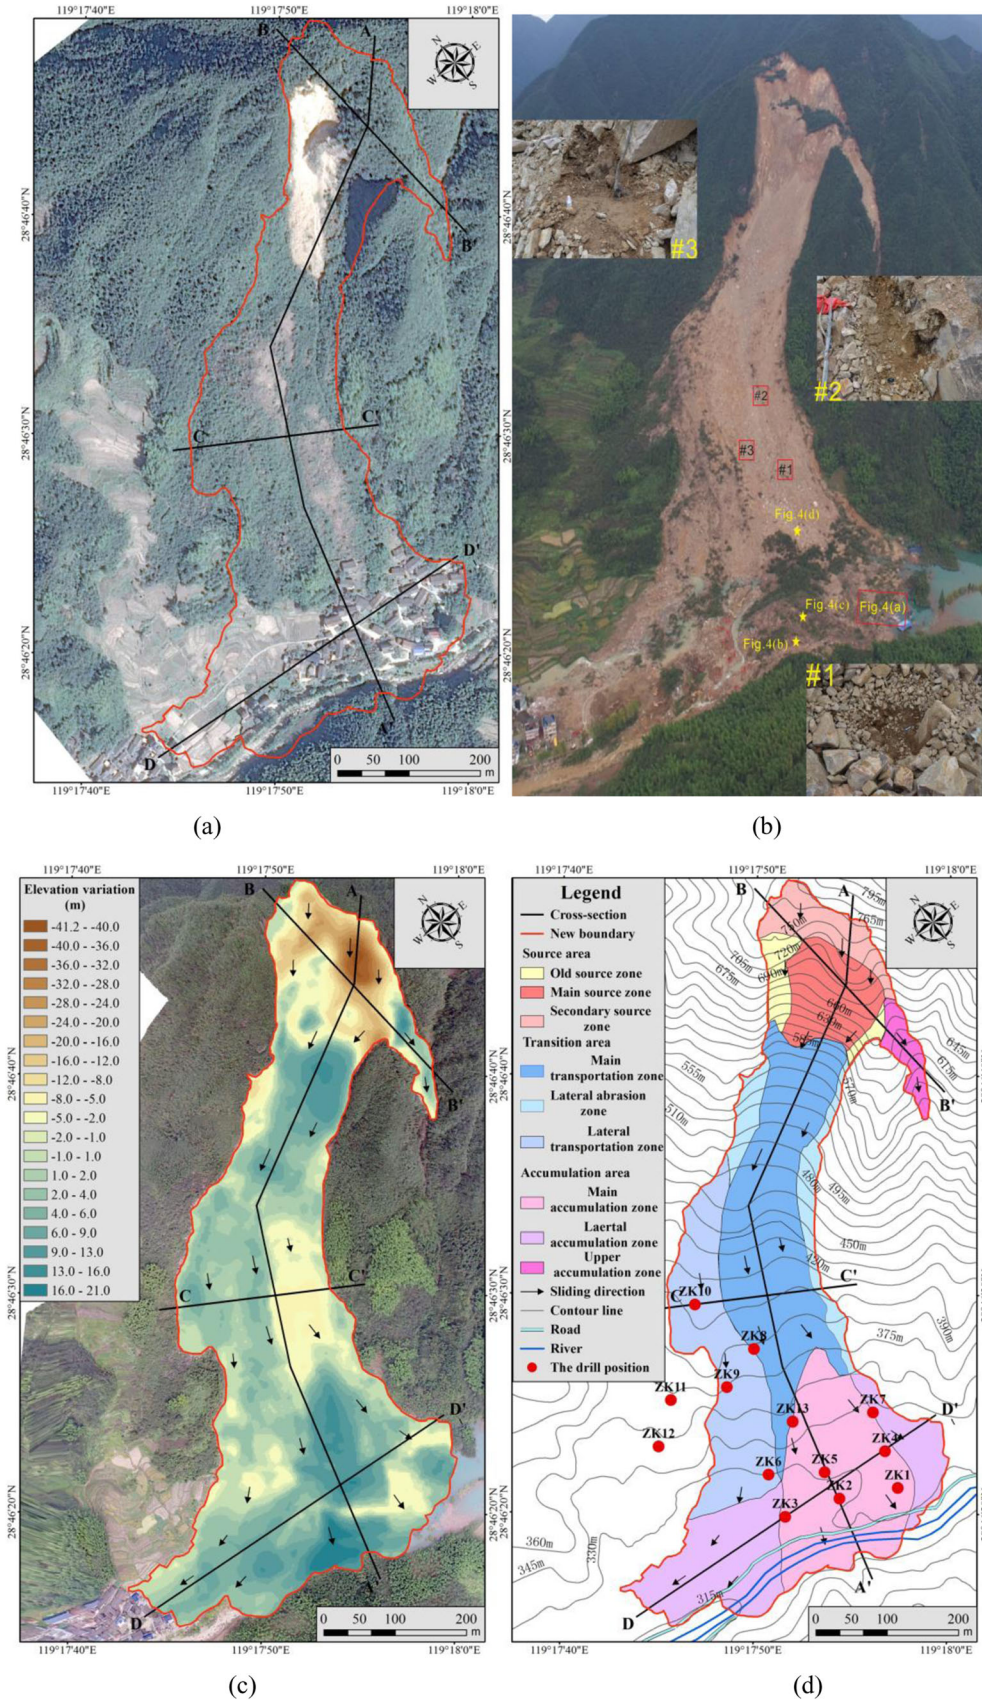
The rockslide is located at the top of the mountain behind Su village (Fig. 3a). The elevation of the mountain peak is 871 m a.s.l., and the relative elevation difference between the peak and the village is 531 m. Pre- and post-event images can be viewed in Fig. 3a, b. The elevation variations before and after the slide, as well as the landslide zoning, are shown in Fig. 3c, d. After the slide, the slide mass was mainly composed of crushed rocks (Fig. 4). The rocks are fine-grained monzogranite. The mineral composition of the rockslide is shown in Table 1. Rock and soil samples were collected at three different locations (Fig. 3b). The slide mass is primarily composed of coarse sand and rock. The particle size distribution of three different samples is shown in Fig. 5. Thirteen drill holes after the slide were dug by the third geological group of Zhejiang province. The location of the drilling holes is shown in Fig. 3d. The drilling properties of different layers are listed in geologic profile maps in Fig. 8. The bedrock primarily consists of high- to medium-weathered fine-grained monzogranite. The body

relative altitude difference is approximately 450 m and the runout distance is approximately 1000 m. The topographic profiles in Fig. 8a–d were created using terrain data before and after the rockslide, field data, and drilling data. The area influenced by the rockslide can be generally divided into the source area, the transition area, and the accumulation area (Fig. 3d).

Fig. 3 a Quickbird image from December 13, 2013. b Photograph showing the study area after the rockslide (image taken by UAV on September 29, 2016). c The elevation variations estimated from the pre- and post-failure DEMs. d Topographic map and zoning of the landslide

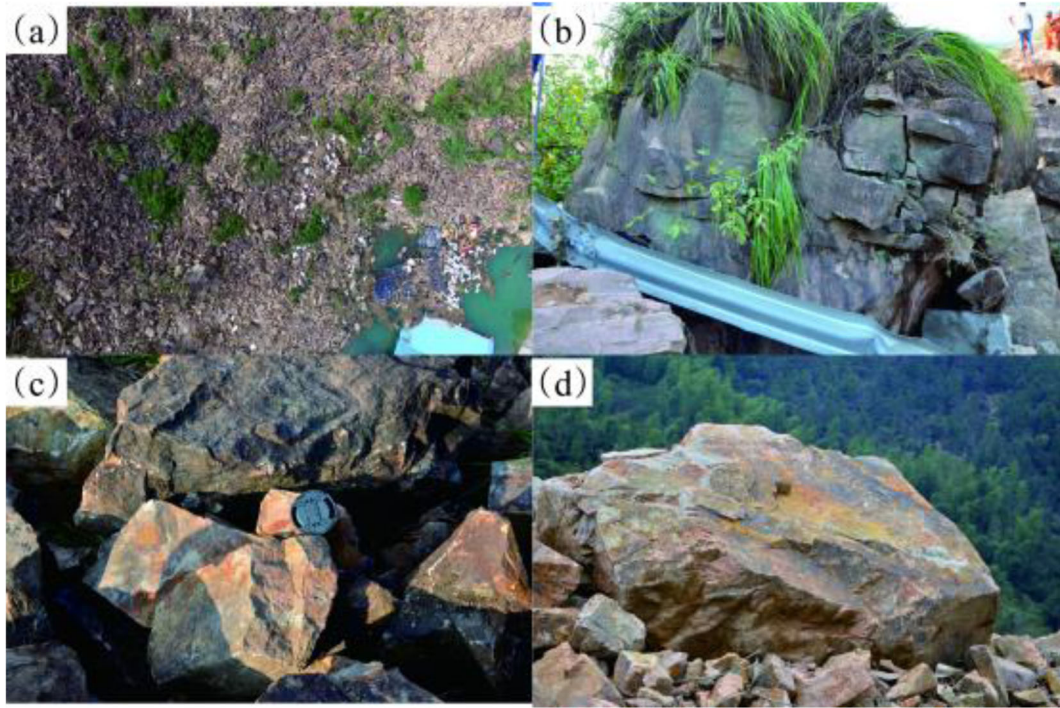
Fig. 4 Photographs of typical rocks in the rockslide. a Aerial view of the deposition area. b Road side fence relocated by tens of meters. c Rocks. d Huge rock

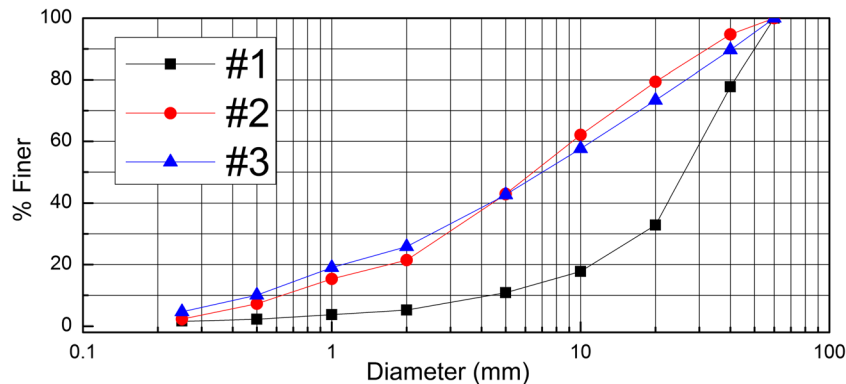
Fig. 5 Chart showing the particle size distribution of three rockslide samples

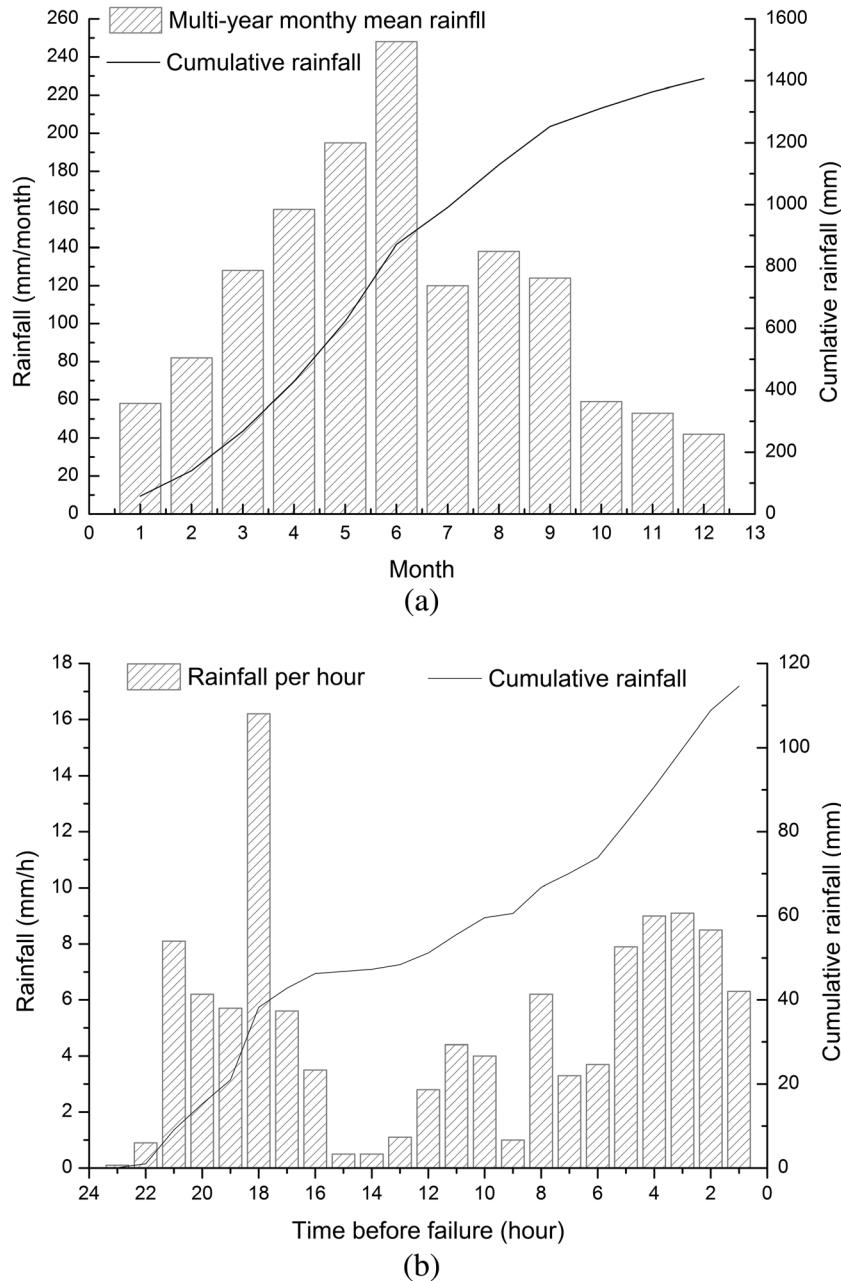
The study area is largely covered by artificially planted bamboo. The study area has a middle subtropical monsoon climate with a mean annual temperature of 16.8 °C. Average monthly precipitation data of Lishui municipality is shown in Fig. 6a. The mean annual precipitation is 1407 mm. Approximately 80% of precipitation is concentrated between March and September. The precipitation 24 h before the slide was collected at the Wangzhaiqiao rainfall station, which is approximately 1 km away. Due to typhoon Catfish, the cumulative rainfall within 24 h of the slide at the Wangzhaiqiao rainfall station was 114.6 mm, as shown in Fig. 6b. It is almost close to the average value 124 mm in September. The sustained rainfall played a significant role in initiating failure of the rockslide.

Fig. 6 a The average monthly precipitation data of Lishui municipality. b Rainfall in 1-h intervals and cumulative rainfall before the slide. Data was collected at the Wangzhaiqiao rainfall station (about 1 km away)

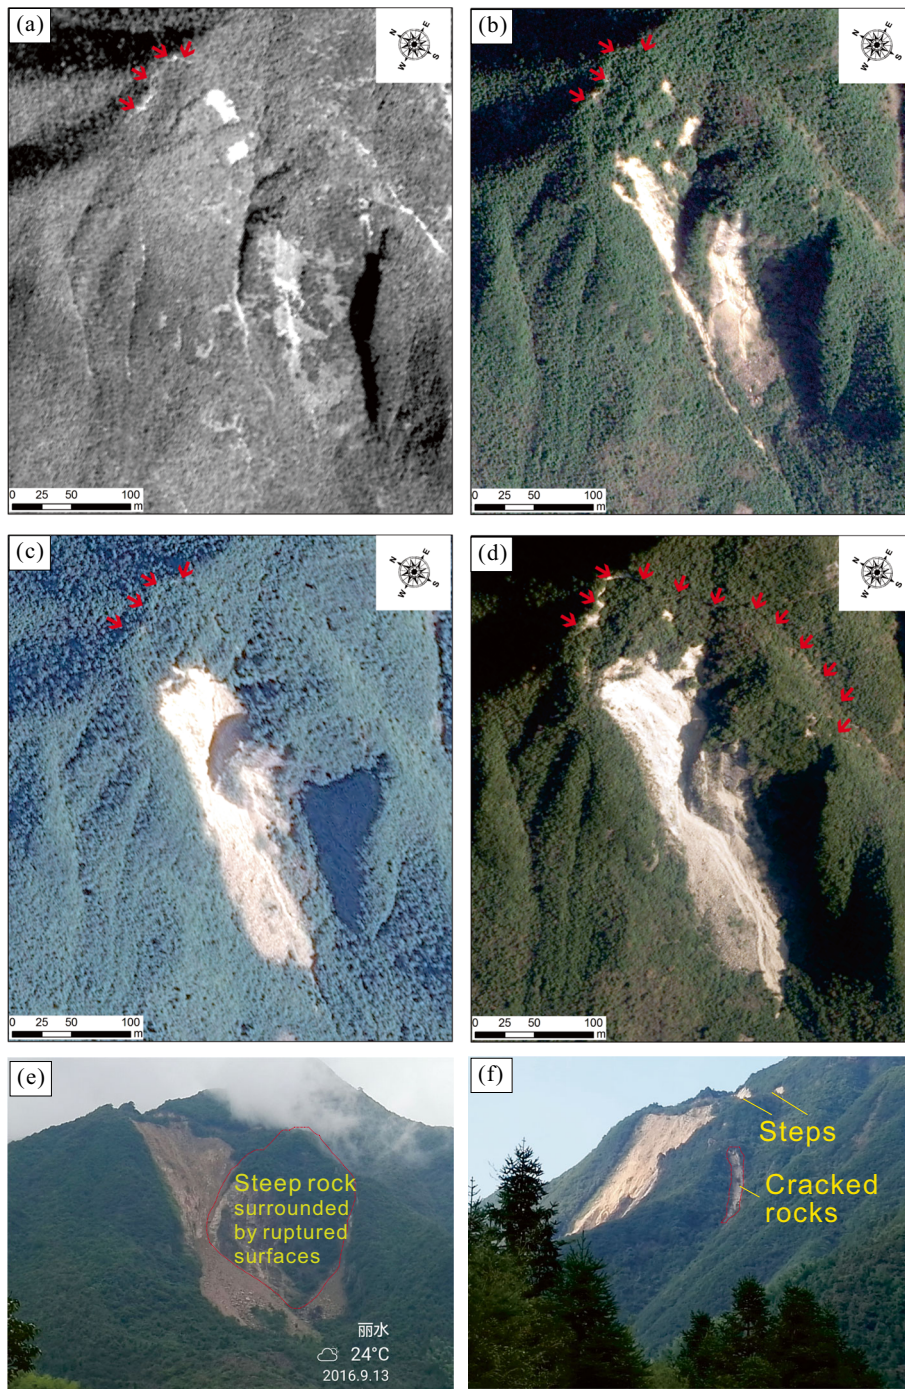
In order to analyze the failure mechanisms of the rockslide, four high-resolution remote sensing images from KeyHole with 2 m precision from 2000 and Quickbird with 0.6 m precision in 2010, 2013, and 2015 and photos before the disaster are examined. As shown in Fig. 7a, obvious surface deformation is visible in the KeyHole images from 2000. Tensile fractures can be seen behind the rear of the rockslide. In addition, a naked collapsed surface

without vegetation is visible, which is consistent with descriptions from villagers. One villager said there were frequent rockfalls within a short distance in the past decade. In 2010, a larger area of exposed rock surface became visible (Fig. 7b). From 2013 to 2015, the unstable zone continued to enlarge (Fig. 7c, d). An arcuate shape marked by red arrows in Fig. 7d formed. At this stage, the exposed surface is primarily located in the west portion of the source area. The area was classified as a high-risk area by local administrators. On September 27, one day before total failure, a more intense rockfall was noticed. The village was evacuated and most of the residents were moved to safe locations. Unfortunately, some people returned to their home as the rainfall stopped. Several photos before the rockslide were taken by local geologic surveyors. It is worth noting that a huge steep rock, which was close to vertical and marked by a dotted line in Fig. 7e, evolved fast. On September 13, more collapsed deposits accumulated on the west side of the steep rock. A new deep gully in the east part of the rock also formed. From the side view in Fig. 7f, another gully was deposited by collapsed rocks. All the rock around the steep rock had been broken by this time. Meanwhile, a high vertical step with tens of meters of offset was found at the top of the steep rock. Thus, for the steep rock, the front was free and the back was pushed by a mass of broken rocks. These conditions along with

marked by the red dotted line in Fig. 7e. The mass behind the main source zone becomes unstable and moves after the steep rock collapses. The mass moved a relatively short distance and it is defined as the secondary source zone. From post-disaster UAV images in Fig. 8b, some land covered by unspoiled trees is present in the source area.

Fig. 7 Photographs of the source area for the Su village landslide. **a** KeyHole image taken in 2000. **b** Quickbird image taken in 2010. **c** Quickbird image taken in 2013. **d** Quickbird image taken in 2015. **e** Front photo taken on September 13, 2016. **f** Side photo taken on September 26, 2016

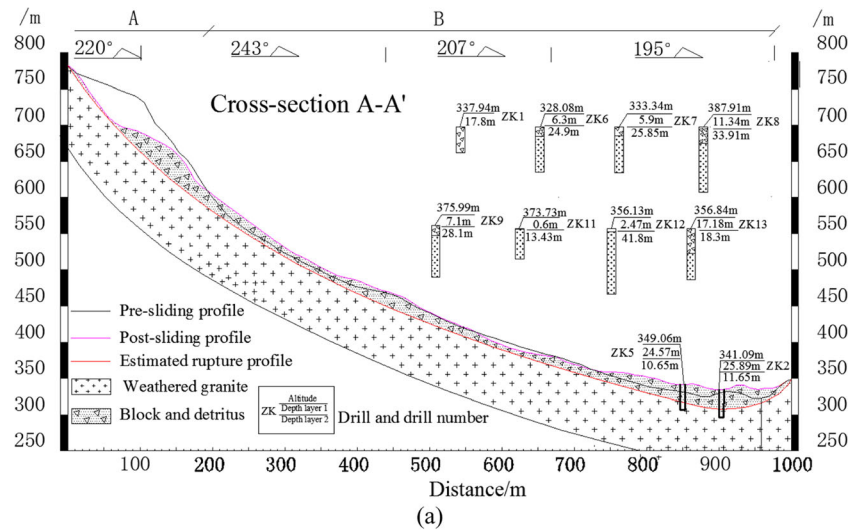
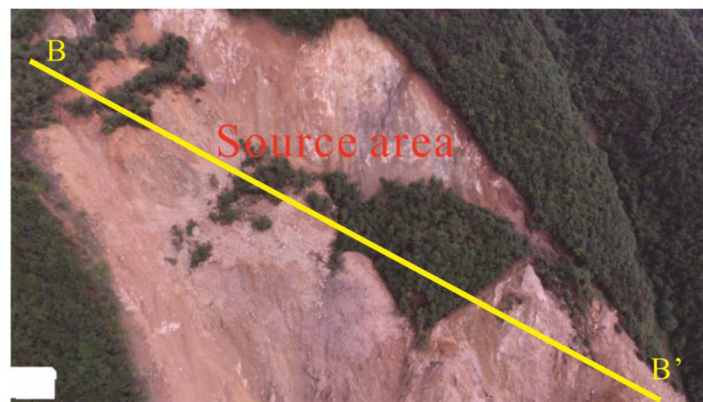
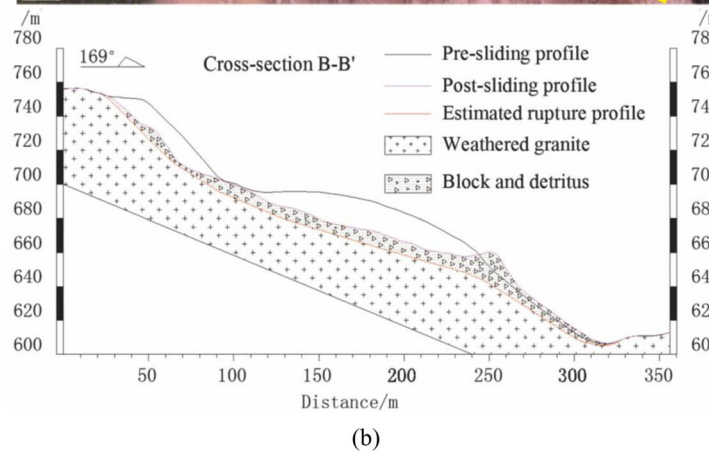
The initial failure area is located at the top of the mountain approximately 700 m a.s.l. From the main profile in Fig. 8a, the

Fig. 8 Geologic cross sections along the a main sliding profile A-A', b transverse profile B-B', c transverse profile C-C', and d transverse profile D-D'

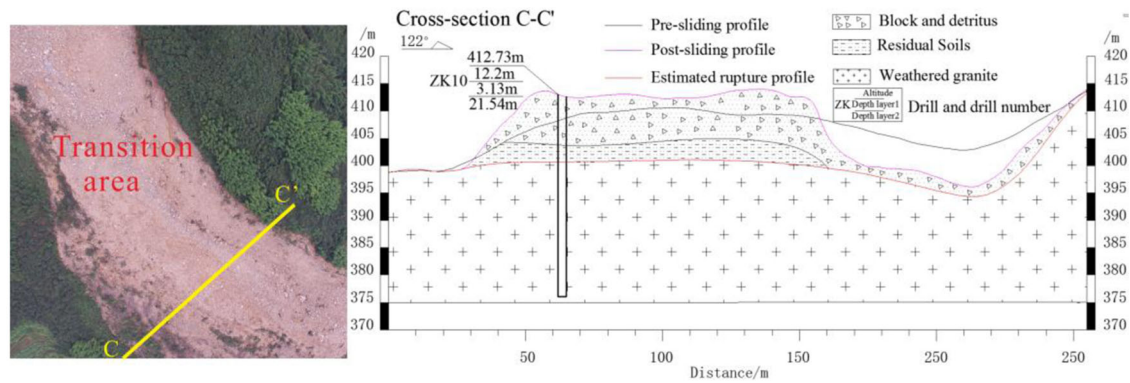
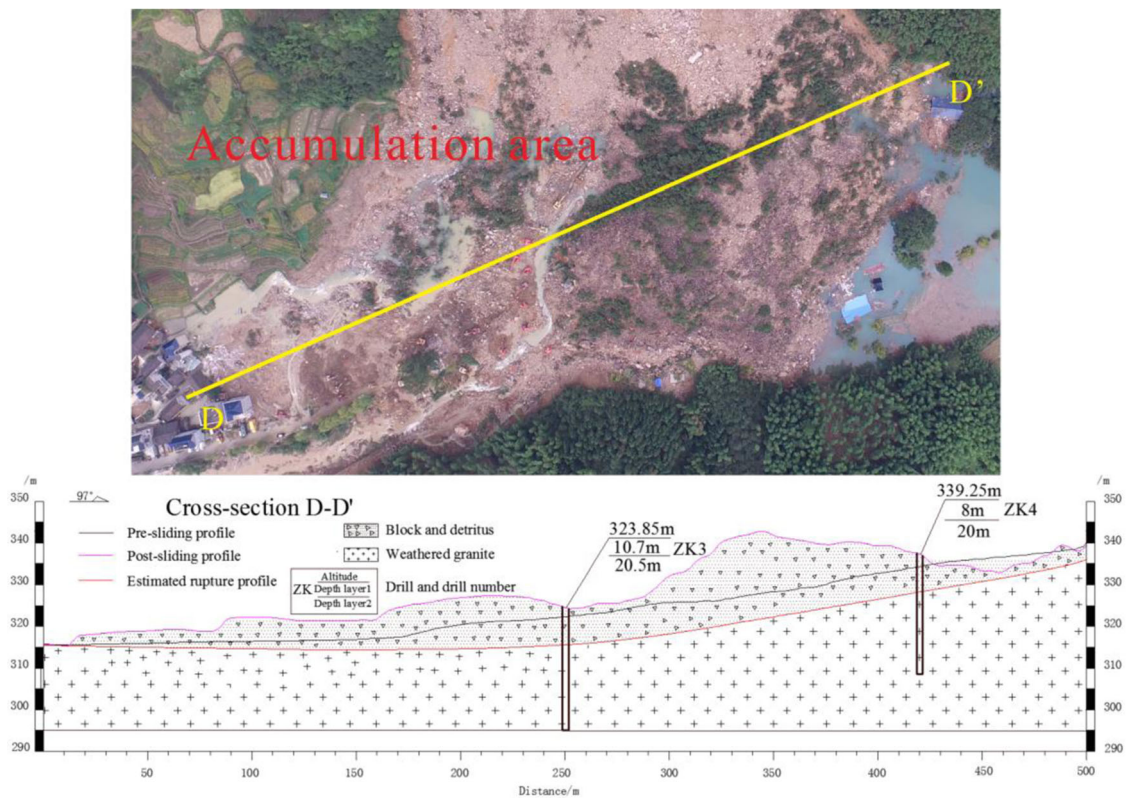
composed of eluvium. From the video and field investigation, the eluvium is restarted and the entrainment effect is apparent during the movement. Due to the influence of topography, the sliding direction deflected eastward about 36° . In the transition area, rocks gradually disintegrated into smaller fragments during the slide. Based on morphological characteristics, the transition area is divided into the main transition zone, lateral transportation zone, and lateral abrasion zone. The main transition zone is the fast-moving zone with the initial fragmented rocks. The large high-speed mass eroded the material along its slide. From the transverse profile C–C' in Fig. 8c, basal entrainment is apparent and the

mountain. Most of the rock mass was deposited in the main accumulation area. The maximum depth of the deposited mass is more than 25 m. From the transverse profile D-D' in Fig. 8d, the area was almost covered by thick deposition in the main and lateral accumulation zones. Houses and roads in the terrace were totally wiped away due to the strong impact of the slide. The moving mass was blocked by the hill on the opposite side and was deposited in the valley.

Fig. 8 (continued)

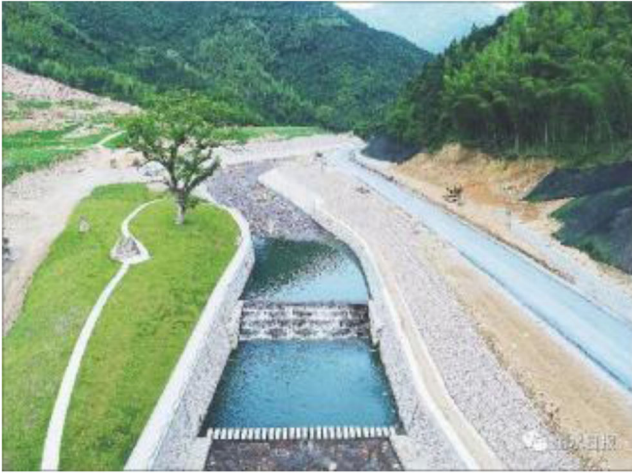
Fig. 9 Image of the valley after reconstruction

During the rescue, the water in the lake was channeled off by digging an artificial waterway through the deposits. New multiple stable terraces were built and eco-engineering for rock slope protection was performed. The river was re-directed and the road was built on the other side of the river. The influenced area was

planned to be a green space and hydrophilic park. An image of the valley after reconstruction can be seen in Fig. 9.
