Landslides (2021) 18:2907–2921
 DOI 10.1007/s10346-021-01701-w
 Received: 23 January 2021
 Accepted: 13 May 2021
 Published online: 21 May 2021
 © Springer-Verlag GmbH Germany
 part of Springer Nature 2021

Catastrophic landslide triggered by persistent rainfall in Sichuan, China: August 21, 2020, Zhonghaicun landslide

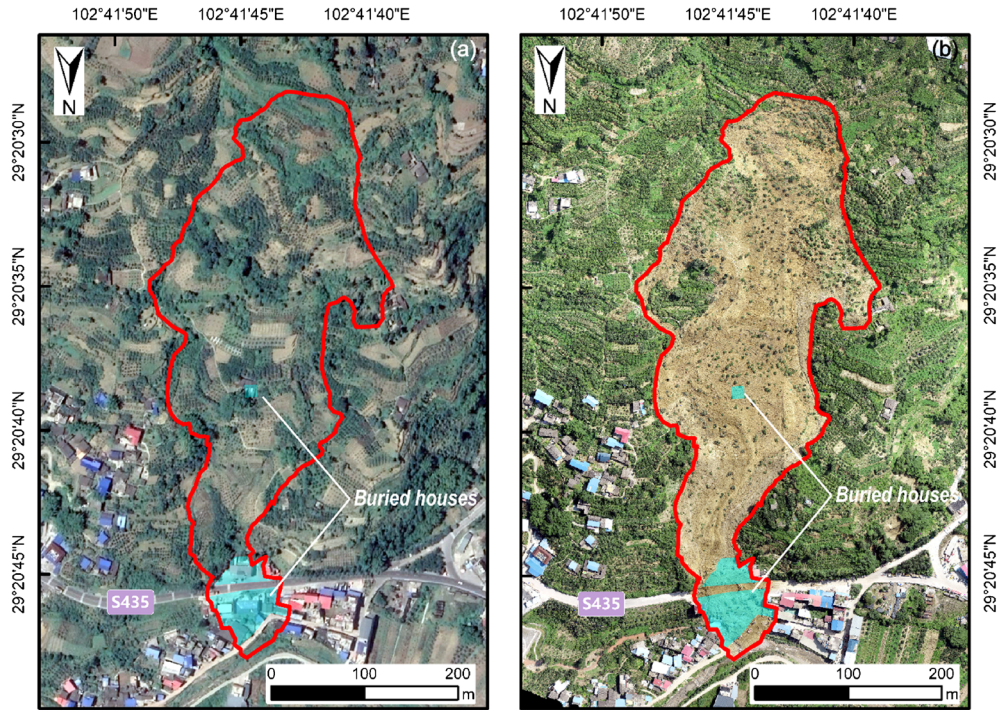
moved to the Liusha River at an elevation of 850 m, and the landslide stopped moving when contiguous houses blocked it. The landslide damaged eight houses and caused traffic disruption on the S435 highway (Fig. 1). Although the local government took evacuation measures before the landslide, due to the lack of understanding of the disaster mechanism and management negligence, the landslide disaster still caused seven deaths, and two people went missing.

Fig. 1 Images of Zhonghaicun before and after the landslide: **a** Google Earth image before the landslide (May 14, 2018); **b** digital orthophoto map (DOM) from the unmanned aerial vehicle (UAV) after the landslide (August 21, 2020)

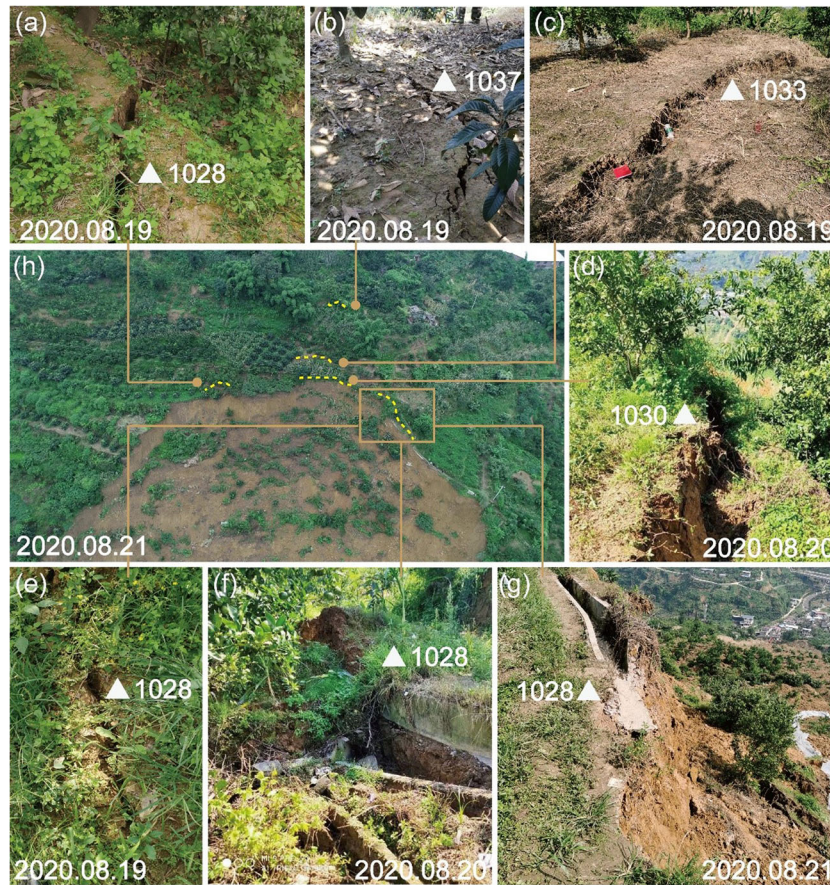
found several tensile cracks in the landslide’s rear crown (Fig. 5a, b, c, e, and h), with an extension length of approximately 2.0–8.0 m and dislocation depth of 5.0–30.0 cm. On the morning of August 20, 2020, observers discovered a new tensile crack at the crown of the landslide (Fig. 5d), with an extension length of approximately 8.0 m and a dislocation depth of 2.0 m. Additionally, the observers found an increase in the extension length and width of the crack shown in Fig. 5e, with a dislocation depth of 2.5 m (Fig. 5d). In the afternoon on August 20, 2020, to avoid the possibility of heavy casualties from the landslide, the Fuquan town government organized to evacuate 55 residents from 14 nearby households. On August 21, 2020, at approximately 3:50 a.m., a landslide occurred (Fig. 5e and h), and nearby residents heard a violent sound and felt the ground shaking. The process lasted for approximately 1 min. Unfortunately, some residents did not comply with the evacuation regulations and returned to their homes without permission, so the landslide caused casualties.

Fig. 5 Tensile cracks in the crown of the Zhonghaicun landslide photographed by inspectors, with the location, elevation, deformation value, and photo time of the crack marked on the image. a–f Tensile cracks before the landslide; e–g photos of tensile cracks at the same location at different times; f UAV image of the rear crown of the Zhonghaicun landslide, with the location and elevation of the crack marked

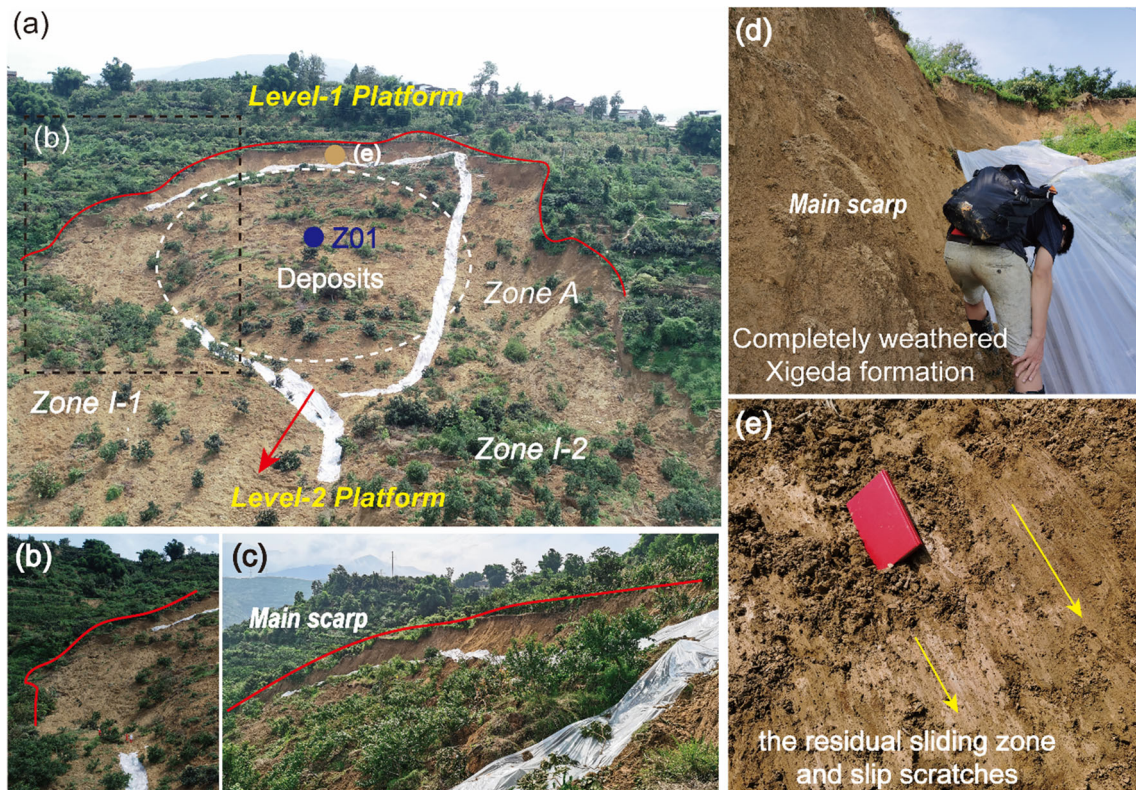
The source area (*Zone A*) is between 990 and 1030 m, with a relative elevation difference of 40 m (Fig. 7a). The source area is 65–140 m wide and 100 m long, and the deposit area is approximately $1.2 \times 10^4 \text{ m}^2$. According to the drilling data, the sliding surface depth is approximately 15.0–27.5 m, and the landslide volume of the source area (*Zone A*) is $27.0 \times 10^4 \text{ m}^3$.

The upper part of the source area is the level-1 gentle slope platform, and the crown and the boundary on both sides of the source area form a ‘round-backed armchair’ landform (Fig. 7a, b, and c). The height of the main scarp is approximately 5–14 m, and the slope is approximately 60° – 80° (Fig. 7d). The sliding scratches on the sliding zone are clear, and the direction of the scratches is consistent with the sliding direction (Fig. 7e). Due to the source area’s instability, most of the sliding material ($\sim 18 \times 10^4 \text{ m}^3$) moved downward and accumulates in the middle and lower parts of the slope, and some of the sliding material ($\sim 9.0 \times 10^4 \text{ m}^3$) remained in the middle and lower parts of the source area (Fig. 7a).

Fig. 7 Photos of the source area (Zone A) of the Zhonghaicun landslide: **a** an overview of the source area (Zone A); **b–c** the main scarp of the Zhonghaicun landslide; **d** the main scarp with completely weathered Xigeda Formation; **e** the residual sliding zone and slip scratches

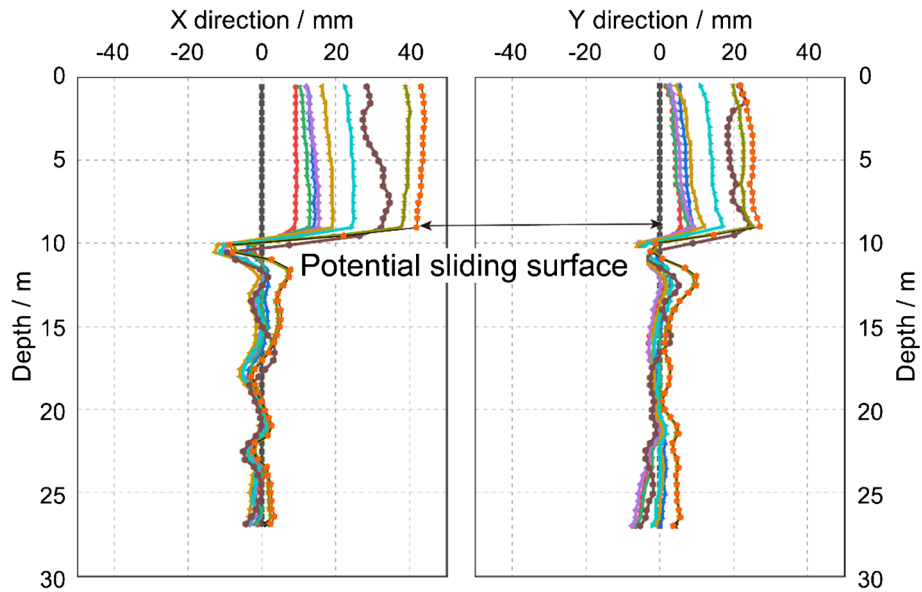
After the landslide, an inclinometer was installed in the Z01 drill hole in the source area (Figs. 6b and 7a). The displacement data show that a new sliding surface is gradually formed at 9.5 m,

and the maximum displacement was 4.5 cm (Fig. 8). In the future, rainfall may cause the landslide deposits of the source area to slide.

Fig. 8 The displacement results monitored by inclinometer Z01. The locations of the inclinometers are listed in Fig. 7b, and monitoring occurred from September 10, 2020, to September 30, 2020

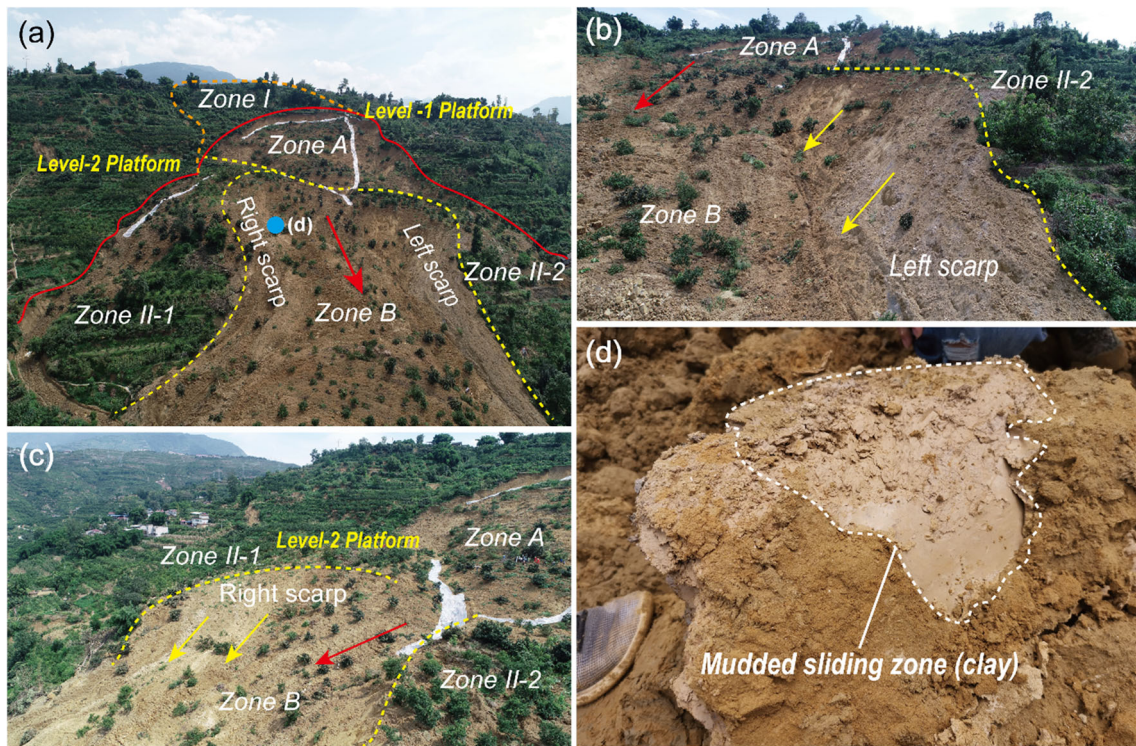
The impact sliding area (*Zone B*) is located below the source area (*Zone A*) at elevations of 940–990 m. The plane shape is approximately zonal, and the area is approximately $1.5 \times 10^4 \text{ m}^2$ (Fig. 9a). Before the landslide, the upper part of the area was a level-2 platform with a slope of approximately 10° . Under the impact load of loose accumulation in the source area (*Zone A*), sliding failure occurred in the impact sliding area (*Zone B*). After the failure of the impact sliding area (*Zone B*), a landslide scarp (Fig. 9b and c) with an elevation difference of 7–14 m was formed on both sides. During the field investigation, a residual sliding zone was found near the right scarp. After removing the clay with a high gravel content on the surface, a smooth mudded sliding zone with a thickness of approximately 2 cm can be seen (Fig. 9d).

Fig. 9 Photos of the impact sliding area (Zone B) of the Zhonghaicun landslide: a an aerial view of the source area; b–c the left and right scarps of the Zhonghaicun landslide; d the mudded sliding zone in the impact sliding area

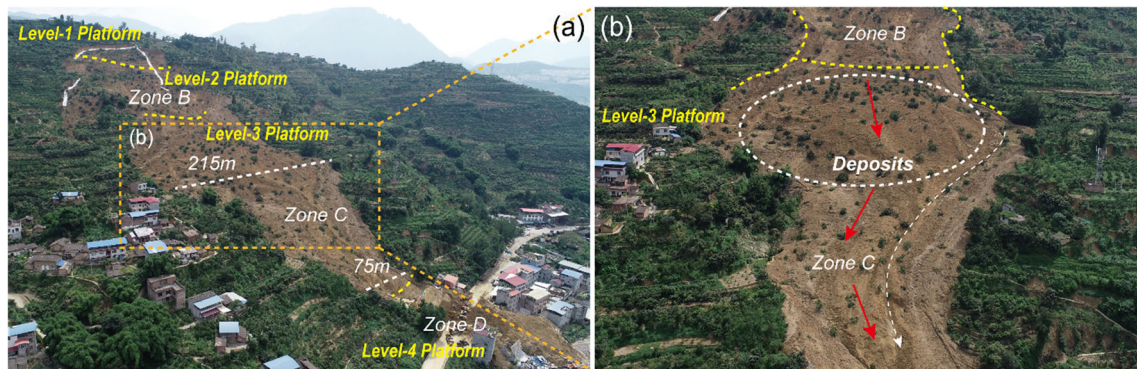
a slope of approximately 8° – 12° , and much landslide debris accumulated on the level-3 platform (Fig. 10b). There are multistage scarps, with slopes of approximately 10° – 20° in the lower part of the shoveling-accumulation area (Zone C). To release its energy, the high-speed debris flow sliding along the terrain continuously

Fig. 10 The shoveling-accumulation area (*Zone C*) of the Zhonghaicun landslide: **a** the landslide deposits remaining in the shoveling-accumulation area; **b** the width and movement direction of debris flow change due to topography

m (Fig. 10a), and the sliding direction was deflected from 25° to 355° (Fig. 10b).

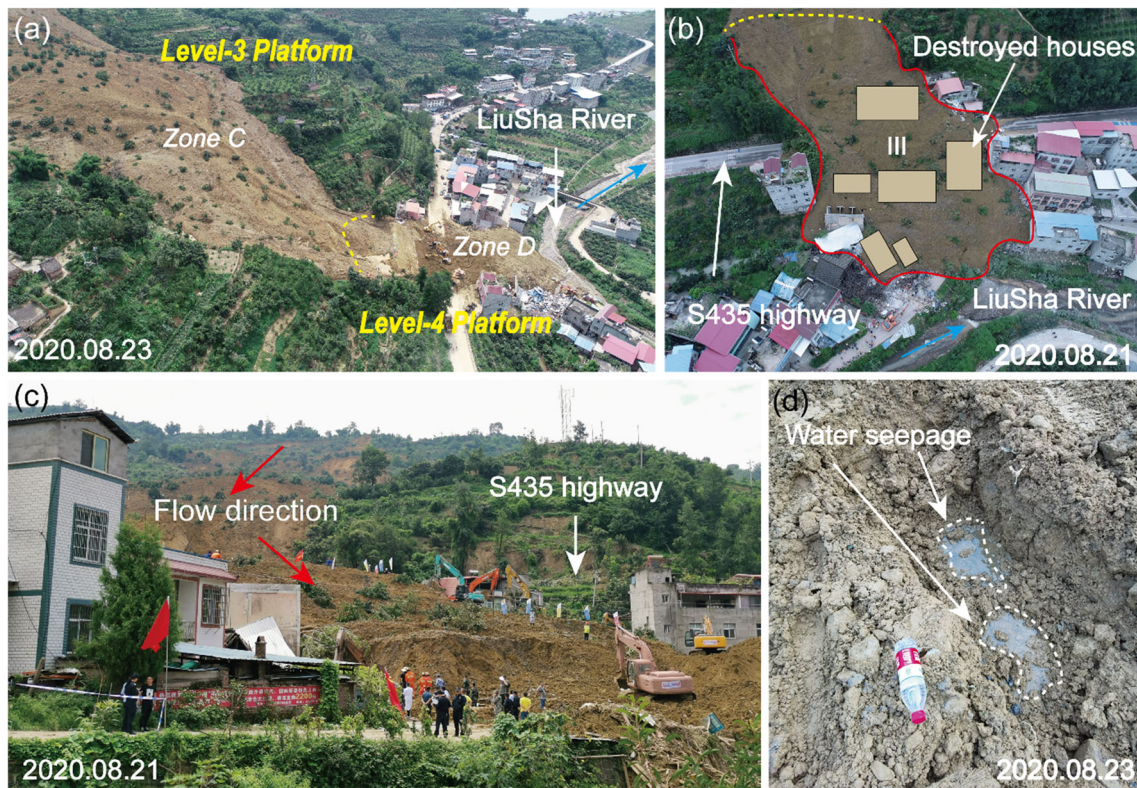
The accumulation area (*Zone D*) is between 870 and 850 m, with an elevation difference of approximately 20 m and an area of approximately $0.82 \times 10^4 \text{ m}^2$ (Fig. 11a and b), and the S435 highway crosses it. The main residential area before the landslide is shown in Fig. 1a. When the landslide occurs, the debris flow is controlled by the terrain and washed down the slope. Finally, the landslide stopped moving after being blocked by houses and accumulated on the left

bank of the Liusha River (Fig. 11b and c). During the field investigation on August 23, water seepage phenomena were found after excavation in the accumulated mass at the slope toe (Fig. 11d).

Fig. 11 The accumulation area (*Zone D*) of the Zhonghaicun landslide: **a** geomorphological characteristics of the front part of the Zhonghaicun landslide; **b** many buried houses in the landslide accumulation area; **c** debris flow material in the toe/accumulation zone; **d** water seepage in debris flow at the slope toe

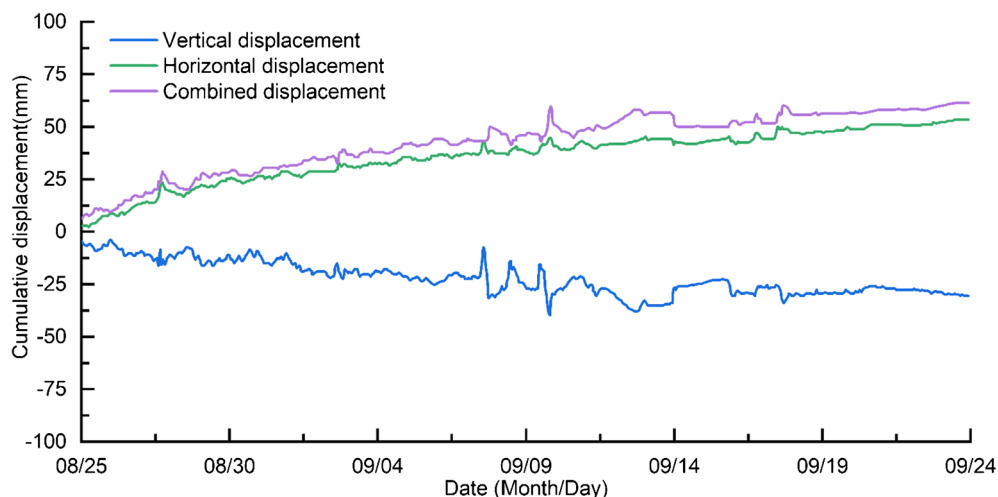
After the landslide, global navigation satellite system (GNSS) surface displacement monitoring station G01 (Fig. 7b) was installed in the traction deformation area (*Zone I*). From August 25, 2020, to September 23, 2020, the cumulative horizontal displacement of G01 was 37.5 mm, the cumulative vertical displacement was 22.3 mm, and the combined displacement was 43.63 mm (Fig. 12). The monitoring data show that the initial deformation rate was higher due to slope stress adjustment after the landslide. After some time, the deformation rate tended to stabilize and enter the stage of constant velocity deformation, and the overall sliding failure seems unlikely. However, there were many tension cracks in the slope, which were conducive to rainfall infiltration. A rainfall intensity lower than the current rainfall intensity may cause instability in the region in the future.

**Fig. 12** Displacements in the traction deformation area (*Zone I*) recorded by the BeiDou-based monitoring system

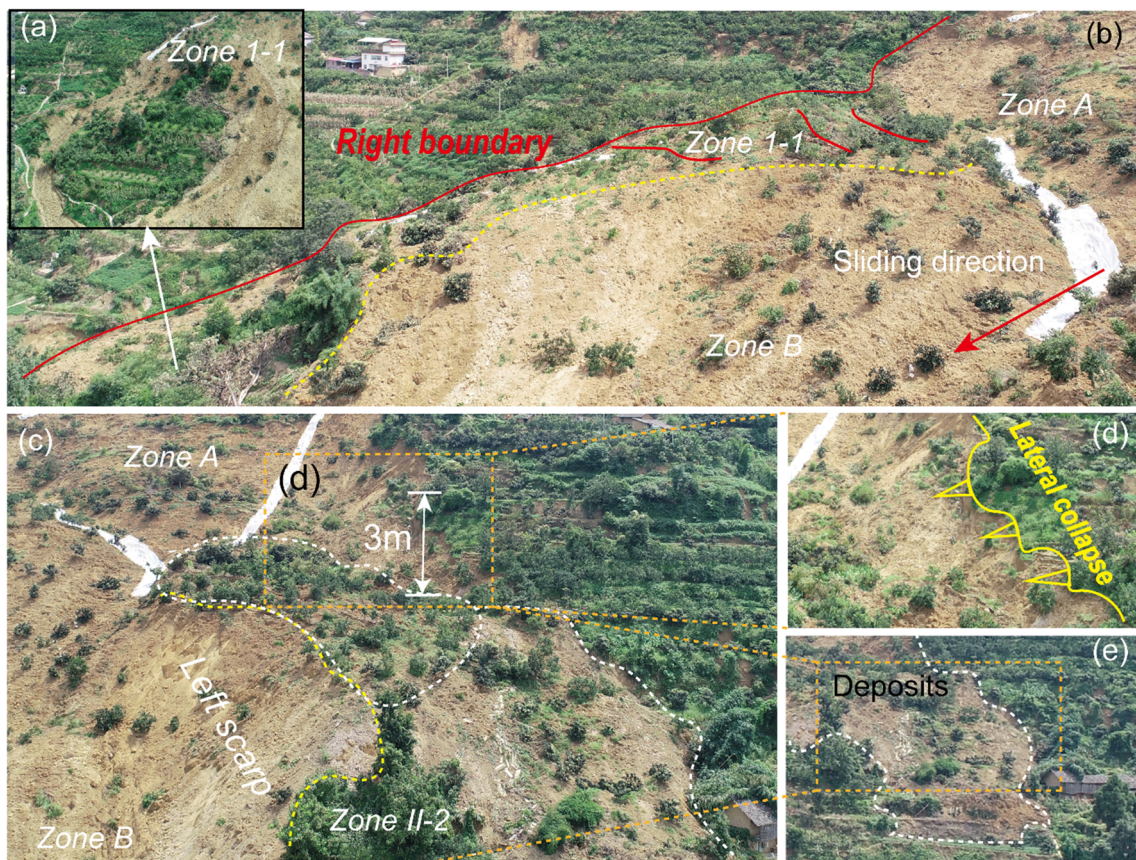
the field investigation, multiple cracks (Fig. 7b and Table 2) were found on the slope of *Zone II-1*; these cracks were mainly distributed on the level-2 platform near the source area (*Zone A*) and had strike angles of 70° – 110° , which were parallel to the main scarp of the source area (*Zone A*). Due to blocking by the level-2 platform, the impact of landslide material on the lower part of *Zone II-1* was low, and the original vegetation of the slope was not affected (Fig. 13a and b). Since the west side of the level-2 platform of the initial slope was lower than the east side, the platform in the *Zone II-2* area close to the source area (*Zone A*) was affected by the impact and traction, resulting in greater deformation than that in *Zone II-1*. The left boundary formed a scarp of 1–3 m (Fig. 13c), and some debris was deposited on the slope below the platform (Fig. 13d).

Fig. 13 The impact-traction deformation area (*Zone II*) of the Zhonghaicun landslide: a–b the impact-traction deformation area (*Zone II-1*) on the right side of the landslide; a is located in the lower part and is not covered by landslide deposits, and b is located on the upper platform with intense deformation. c–e The impact-traction deformation area (*Zone II-2*) on the left side of the landslide; d is located on the upper platform with intense deformation, and e is located at the lower part and covered by landslide debris

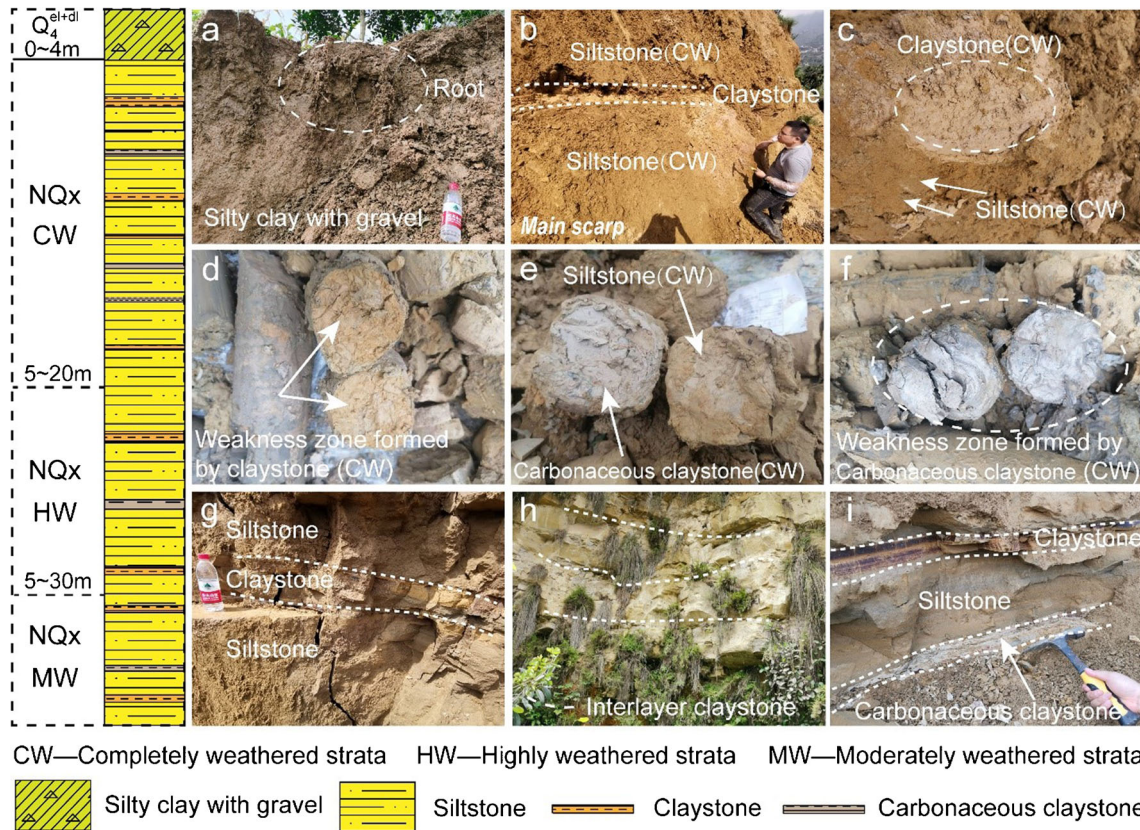
potential sliding surface (Rahardjo et al. 2005; Wang et al. 2020). According to field investigation and drilling data, the sliding zone of the Zhonghaicun landslide is composed of thin claystone and carbonaceous claystone with a thickness of 0.1–0.3 m in the completely weathered Xigeda Formation. When they are saturated, these weak intercalations easily soften and eventually become the sliding zone of landslides.

Fig. 15 The distribution characteristics of weak interlayers based on field investigation and borehole data: a silty clay of residual slope deposit on the landslide crown; b–c stratigraphic structure of completely weathered Xigeda Formation discovered by field investigation; d–f weak interlayers in completely weathered (CW) Xigeda Formation revealed by drilling; g–i highly weathered (HW) Xigeda formation with weak interlayers; i moderately weathered (MW) Xigeda Formation with weak interlayers

and the pore water pressure cannot be quickly dissipated by drainage due to the blockage of the channel. The impact load will sharply increase the total stress and pore water pressure, leading to a rapid decrease in shear strength (Duan et al. 2020). With the rapid decrease in the anti-sliding force and the increase in the sliding force, the sliding surface of the impact sliding area (*Zone B*) penetrates rapidly and slides downward. This fact can be confirmed by the appearance of a flat and smooth sliding surface revealed by field investigation (Figs. 9d and 15c).

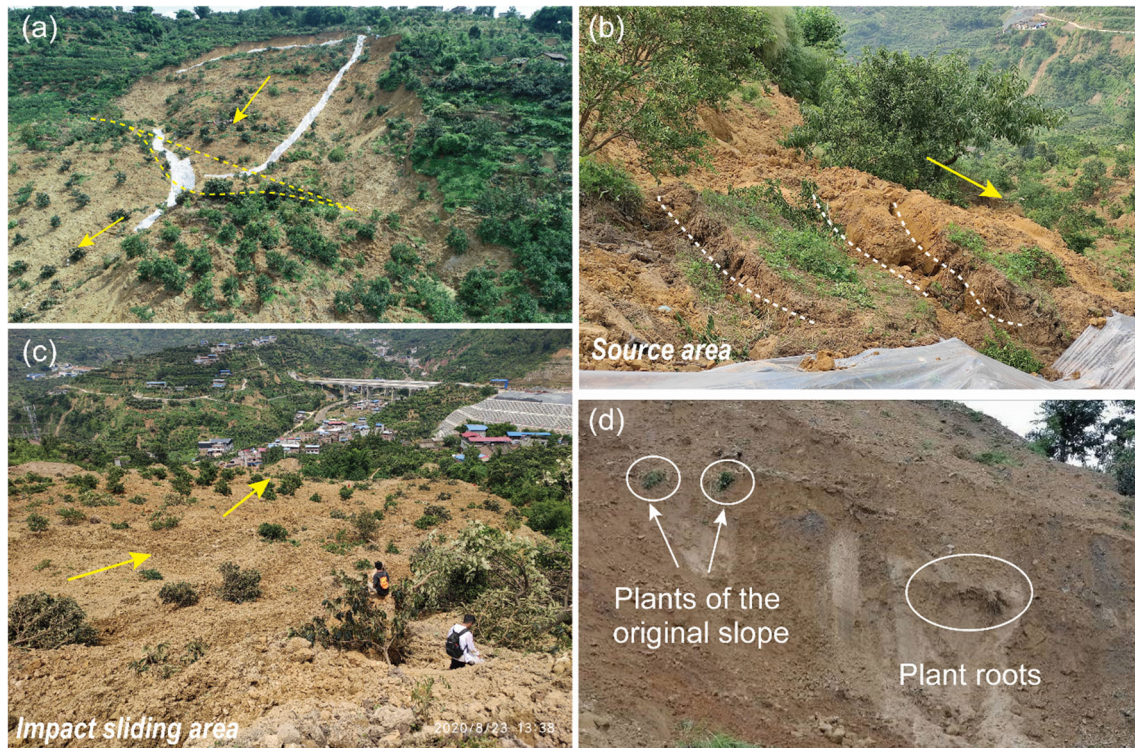
Fig. 17 Field investigation evidence of landslide movement characteristics. **a** wedge-shaped opening in the impact sliding area; **b** the sliding mass in the source area is not completely disintegrated; **c** the sliding mass in the impact sliding area is loose; **d** the original slope in the impact sliding area is covered by sliding mass

After the sliding of the source area, a part of the sliding mass impacted the critical state slope at the lower part, which led to the rapid penetration of the sliding surface in the impact sliding area and the high-speed downward sliding. The landslide formed a wedge-shaped opening in the middle of the slope (Fig. 17a). The field investigation found that the sliding mass in the source area is not completely disintegrated, and there are many tension cracks on the surface (Fig. 17b). In contrast, the sliding mass in the impact

sliding area is loose, and there are no tensile cracks on the slope surface (Fig. 17c). The vegetation between the sliding mass and the initial slope can be seen in the scarp on the left side of the impact sliding area (Fig. 17d). The geomorphic characteristics after the failure reflect the multiple sliding process of the Zhonghaicun landslide. The impact of the first sliding on the lower slope was the main reason for the lower slope sliding. Subsequently, the saturated landslide mass formed long-distance flow-like movement under the action of gravity and impact (Figs. 10 and 11). Finally, affected by the microrelief of the slope and the house, the sliding direction changed (Fig. 10b) and the landslide stopped moving forward (Fig. 11b).

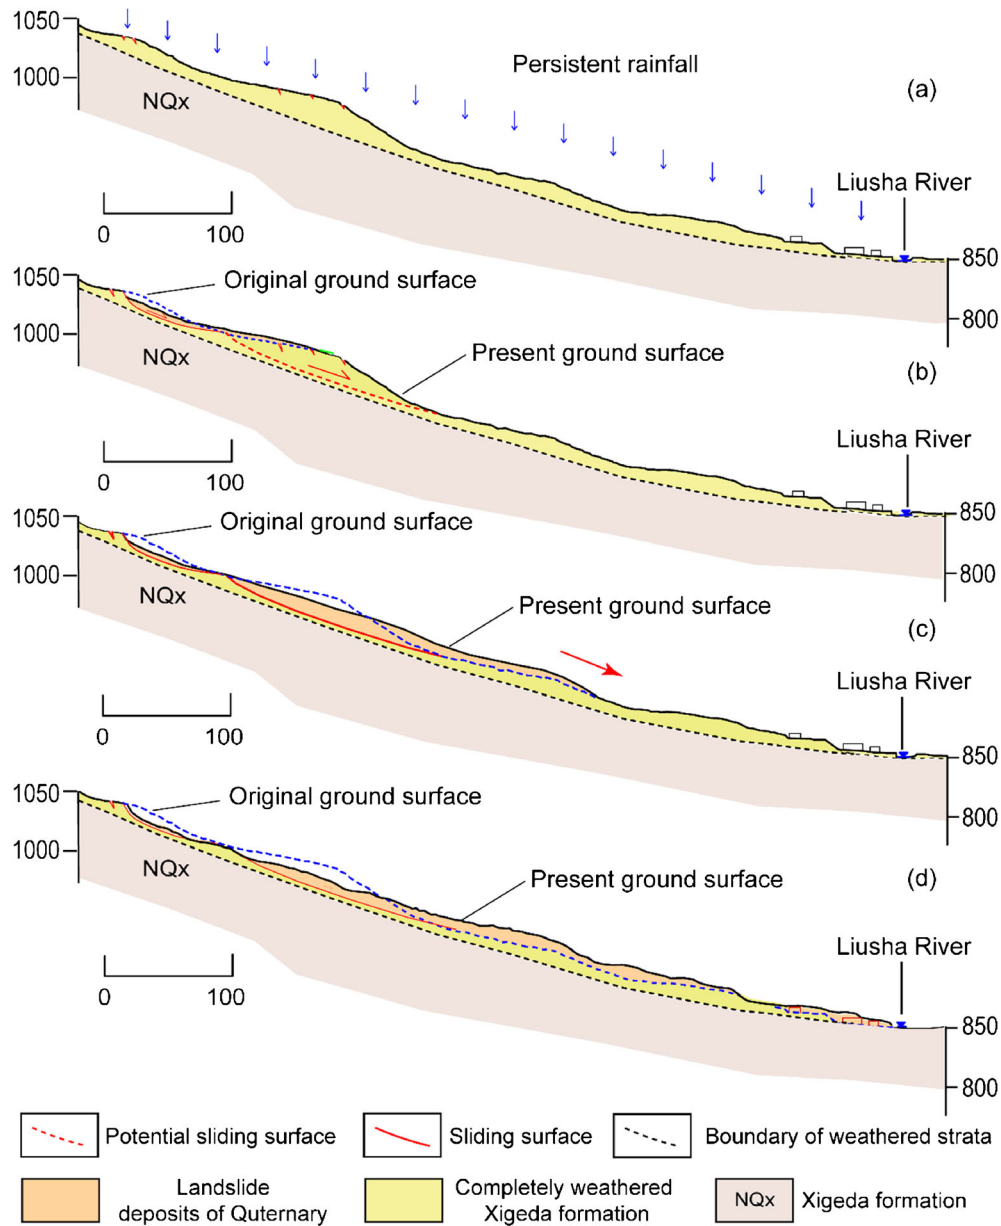
Fig. 18 Conceptual model of the evolution process of the Zhonghaicun landslide: a slope deformation stage; b sliding and overlay stage; c secondary sliding stage; d flow-like movement stage

- (1) Slope deformation stage (Fig. 18a). Under the effect of continuous rainfall, rainfall infiltration increased the

saturated bulk density of the sliding mass. The rainwater seeped into the weak interlayer of the slope, causing its shear strength to decrease. Over time, tensile stress areas appeared on the slope under gravity, and tensile cracks appeared on the surface.

- (2) Sliding and overlay stage (Fig. 18b). After the rain stopped, the seepage process in the slope continued. With the further deepening of the cracks and the penetration of the sliding surface, the upper slope was damaged, and a large number of landslide materials were loaded on the lower slope in a short time.

- (3) Secondary sliding stage (Fig. 18c). Saturated by the upper landslide, the weight of the lower slope increased and the strength of the saturated sliding zone decreased rapidly under the impact, forming a shear sliding surface through the weak interlayer surface, which led to the instability of the impact sliding area.

- (4) Flow-like movement stage (Fig. 18d). A part of the sliding mass continued to move downward to form a debris flow. In this process, the original soil of the slope was scraped along the sliding path. Because of the buffer of the gentle slope platform and the blocking of houses, the debris flow slowed down due to the loss of kinetic energy until it moved to the front of the Liusha River.>
