# Failure modes classification and failure mechanism research of ancient city wall

**Keywords** Ancient city wall · Failure mode classification · Failure mechanism · Rainfall analysis · Thermo-mechanical coupling analysis

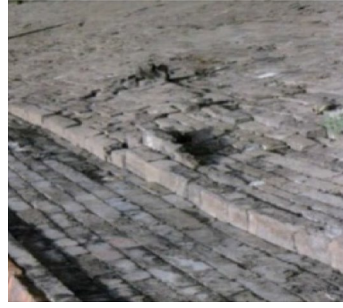
| Failure mode | Subclass | Manifestation | Failure mechanism | Occurrence location | Sketch map | Physical map | Protective measures suggestions |
|---|---|---|--|---|---|--|---|
| | Bulging | Surface bulging near top of the wall | Heavy rainfall infiltrates into cracks and squeezes the soils, leads to a decrease of the shear and causes dilation | Surfaces of city wall | <p>Rainwater infiltration</p> <p>Edge bulging</p> <p>Bilateral extrusion</p> | | Repair the drainage system, fill the holes in the wall surface, and monitor regularly |

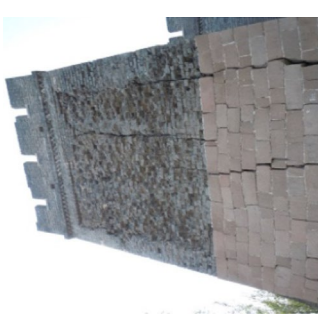
| Failure mode | Subclass | Manifestation | Failure mechanism | Occurrence location | Sketch map | Physical map | Protective measures suggestions |
|---|--|---|---|---|---|--|--|
| Weathering | Wind erosion and spalling on the surfaces of the city wall | Surfaces of city wall | Weathering due to acid rain, corrosion, freezing, and crystallization of soluble salts leads to crack initiation | Surfaces of city wall | | | Increase the strength of the wall, surface protection materials are needed, do monitor regularly |

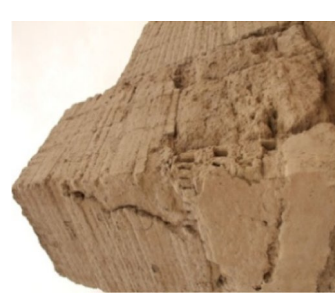
| Failure mode | Subclass | Manifestation | Failure mechanism | Occurrence location | Sketch map | Physical map | Protective measures suggestions |
|---|--|---|---|---|---|--|--|
| Erosion and collapse at the bottom | Erosion and collapse at the bottom | At the bottom of the wall | The stability of the wall decreases due to the effect of wind erosion at the bottom of the foundation | At the bottom of the wall | | | Revamping the foundation, apply surface protection materials |

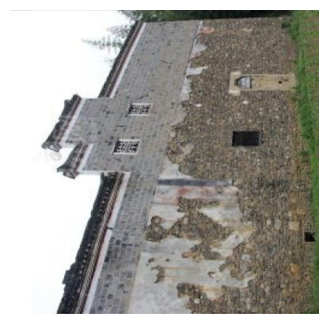
| Failure mode | Subclass | Manifestation | Failure mechanism | Occurrence location | Sketch map | Physical map | Protective measures suggestions |
|---|--|---|---|---|---|--|--|
| Salt efflorescence at the surface | Salt efflorescence at the surface | Surface of the wall | Alkali and salt dissolved in the building materials are crystallized on the surface of the wall, which leads to the spalling of the surface | Surface of the wall | | | Strip the surface, replace damaged bricks, and use alkali-removing agent |

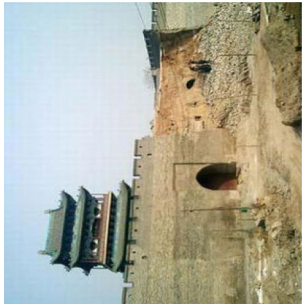
| Failure mode | | Failure mechanism | Occurrence location | Sketch map | Physical map | Protective measures suggestions |
|---|---|---|--|---|--|---|
| Structural factor control | Crack propagation | Sliding collapse of soil mass | Surface of city wall | | | Improve the sealing treatment of the top of the wall (install anchors), and monitor regularly |
| | | The micro-cracks expand unceasingly, which leads to the formation of a sliding surface and to slip failure | | | | |

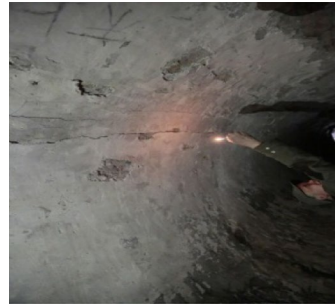
| Failure mode | | Failure mechanism | Occurrence location | Sketch map | Physical map | Protective measures suggestions |
|---|---|---|--|---|--|---|
| | | Structural unstable collapse | Chamber inside the wall or air raid shelter | | | Working on the cement grouting, filling treating of cracks |
| | | Thermal expansion and contraction cause cracking inside the chamber, which may affect the overall strength of the wall and cause collapse | | | | |

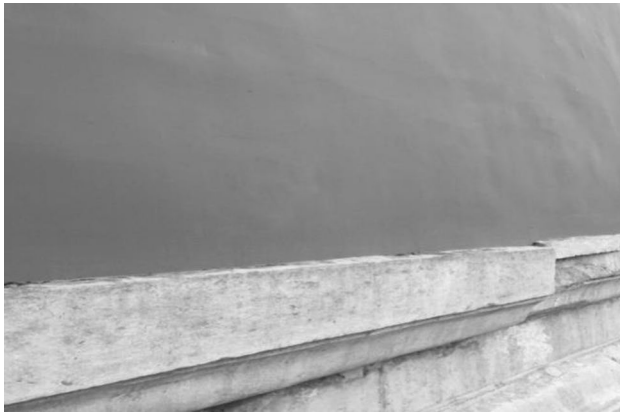
**Fig. 2** Brick dislocation of ancient wall

The state of damage is shown in Figs. 2 and 3. There are cracks at the foot of the wall with brick dislocation phenomena (Fig. 2), which indicate that there may have been uneven settlement of the foundation, and we observed bulging; therefore, the damage of the wall is probably caused by these two failure modes. Figure 3 shows the leakage of water at the foot of the wall, which indicates that there are cracks filled with water inside the wall. If the water cannot be discharged in time, the internal cracks will widen, which may cause spalling at the wall surface or even collapse.

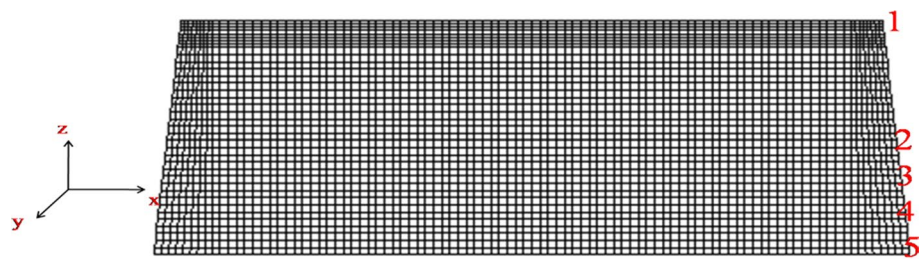
**Fig. 4** Finite element model of the wall and the position of the reference points

The numerical model is a cross section with a thickness of 0.9 m and with the same size as the city wall (36.8 m  $\times$  12.96 m). The wall model is regarded as an isotropic fluid model not taking into account the compressibility of soil. In order to fit with the actual rainfall situation, the mechanical parameters are determined by combining the results of direct shear tests of field samples. Drill hole sampling has shown that the core of the wall was completely composed of brick masonry; therefore, the city wall can be

The rainfall process is simulated by applying the rainfall on the surface of the wall and setting the ground water discharge boundary at the lower surface of the wall. The bottom surface and both sides of the city wall are fixed in the model. The objective of the simulation is to determine the influence of rainfall intensity on the failure of the wall. Five reference points located at the surface of the city wall are selected to monitor the increasing displacement in the  $x$  direction and the development of a plastic zone (Fig. 4). The simulation started with the rainfall on top of the wall, while the groundwater seepage was limited at the surfaces of the wall. Rainfall intensities of 10, 20, 30, and 40 mm/h were simulated for 24 h, while the deformation trend and the formation of a plastic zone were studied (Figs. 5 and 6).

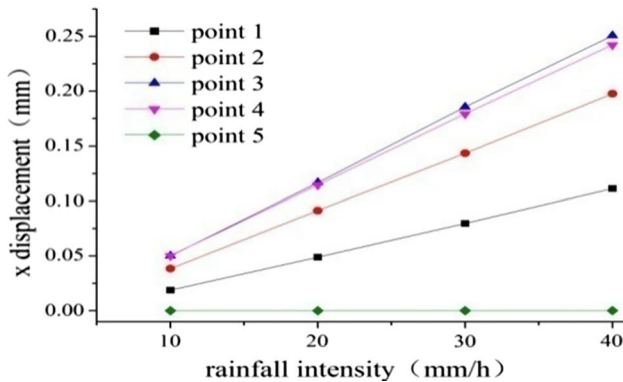
**Fig. 5** Trend of the horizontal displacements of the reference points

Figure 5 shows the deformation trend in the horizontal direction of each reference point on the surface of the wall model, which is mainly concentrated on the lower part of the surface of the wall (Points 2–4), while the deformation at the top (Point 1) and the bottom (Point 5) is small. With the increase in rainfall intensity, the displacements in the horizontal direction increase with a linear growth trend, which indicates that the deformation of the wall is related to the rainfall intensity.

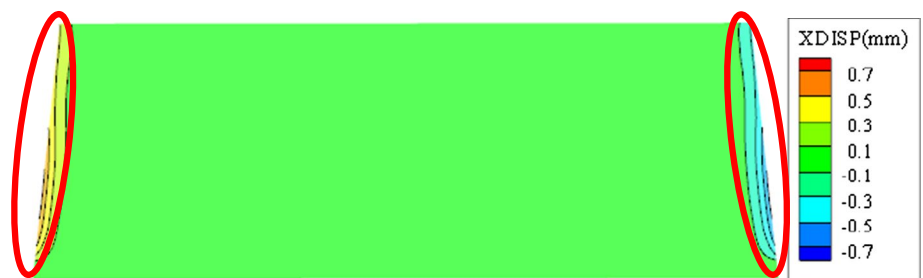
**Fig. 7** X displacement distribution after two heavy rainstorms

In order to obtain more detailed information about behavior of the wall under strong rainfall conditions, we applied repeated continuous heavy rainfall during the numerical model testing. The applied rainfall intensity was 40 mm/h, during two rainstorms with an interval of 1 day. Figure 7 shows the displacements of the reference points in the horizontal direction. After the two rainstorms, the displacements in the horizontal direction are still concentrated on the middle and lower part of the surface of the wall. The maximum displacement is about 0.7 mm (Fig. 7), which is more than twice as much as after a single heavy rainfall (0.25 mm). A comparison with the deformations after a single rainstorm shows that the failure affected areas were expanded at the surface of the wall. After continuous and repeated heavy rain, the wall cracks widened and plastic failures appeared in the middle and lower part of the wall surface (Fig. 8), visible as a local convex bulging phenomenon shown in Fig. 9.

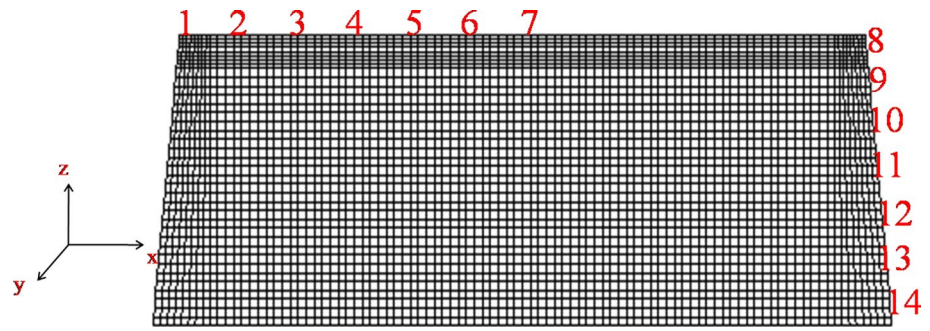
**Fig. 10** Distribution of monitoring points on the thermo-mechanical model

In order to make the internal temperature field match with the actual situation, the bottom surface of the wall was designed that no heat could leak out of the bottom and the temperature was set on the surfaces of the wall. The bottom and both surface sides of the city wall are fixed. The objective of the simulation is to determine the influence of temperature fluctuations on the failure of the wall in two different climatic conditions. Fourteen reference points on the top and the right-hand surface of the model were selected

(Fig. 10) to monitor the deformation of the city wall. The simulation started with the fluctuation of the temperature, with a 20 years cycle from spring to winter.

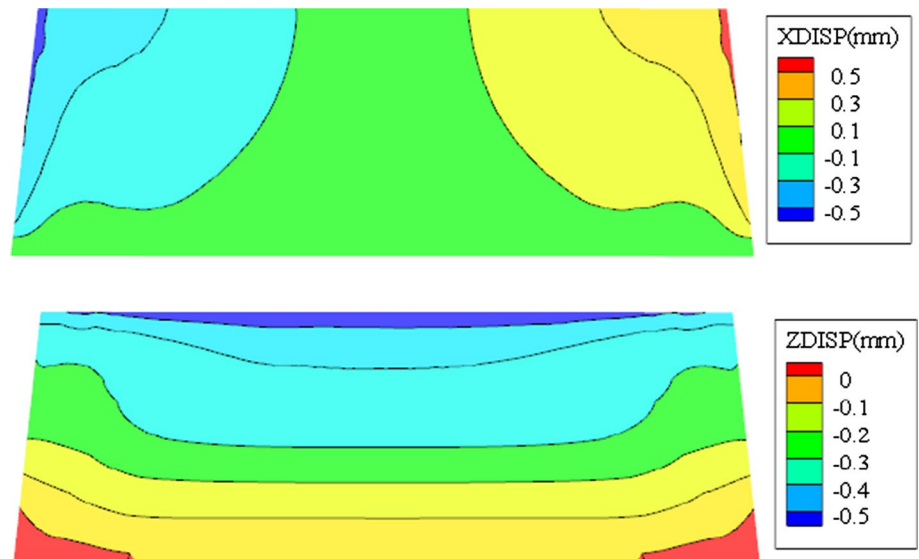
**Fig. 11** Deformation of the wall under normal climatic conditions after 20 years

Figure 11 shows the deformation in the X (horizontal) and Z (vertical) directions of the city wall under average climatic conditions for a period of 20 years. It shows that

under the influence of thermal expansion and contraction, the settlement was mainly concentrated on the top surface with a maximum settlement of 0.5 mm in the 20th year, which is controllable. In the horizontal direction, the model has a symmetrical deformation pattern, with a maximum deformation of 0.5 mm, at both sides of the city wall. It can

be concluded that the settlement is small and will not cause large deformations, indicating that the overall stability of the wall is good under the influence of temperature fluctuations.

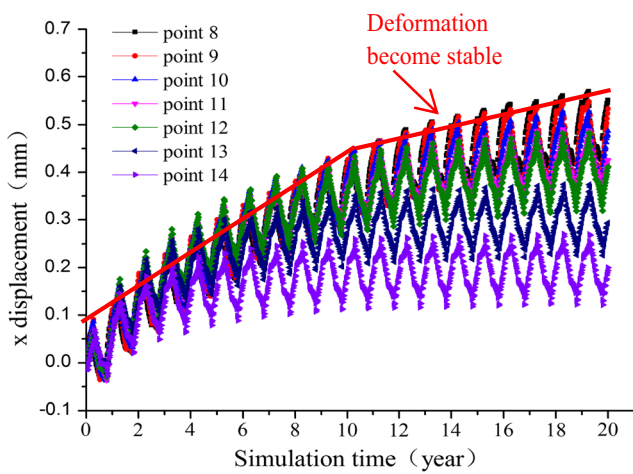
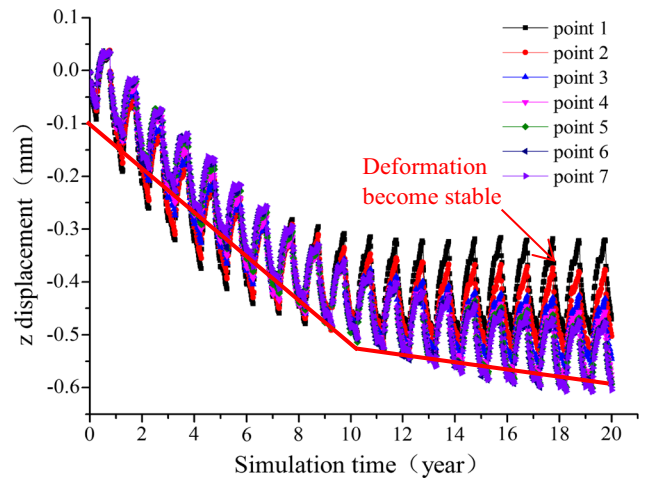
**Fig. 12** Trends of the displacements of all monitoring points under normal climatic conditions. **a** Horizontal displacement, **b** vertical displacement

Figure 12 shows the deformation trend under average climatic conditions for a period of 20 years. With the changes in temperature, the wall undergoes thermal expansion and contraction. It can be concluded that after the temperature has reached a minimum and begins to rise again, the wall bulging deformation occurs at the top of the wall surface, while the wall begins to shrink inward when the temperatures fall. In the horizontal direction, Point 8, which is located at the top of the wall, shows the largest displacement, while point 14, which is located at the bottom of the wall, has the minimum deformation; in the vertical direction, there is no clear difference between the monitoring points and the maximum settlement is about 0.6 mm. During the initial stages of the simulation, the deformation increases greatly. After a simulation time of 10 years, the annual deformation amplitude decreases gradually and becomes stable, with a range of variation of not more than 0.3 mm. This can be explained by the fact that the initial temperature field in the wall was not yet stabilized, which causes the deformation to vary strongly. After the internal temperature field has stabilized, the influence of the temperature field on the deformation has also been eliminated. Therefore, under the premise of a stable temperature field inside the wall, the settlement fluctuates in a smaller range and the wall will not be damaged.

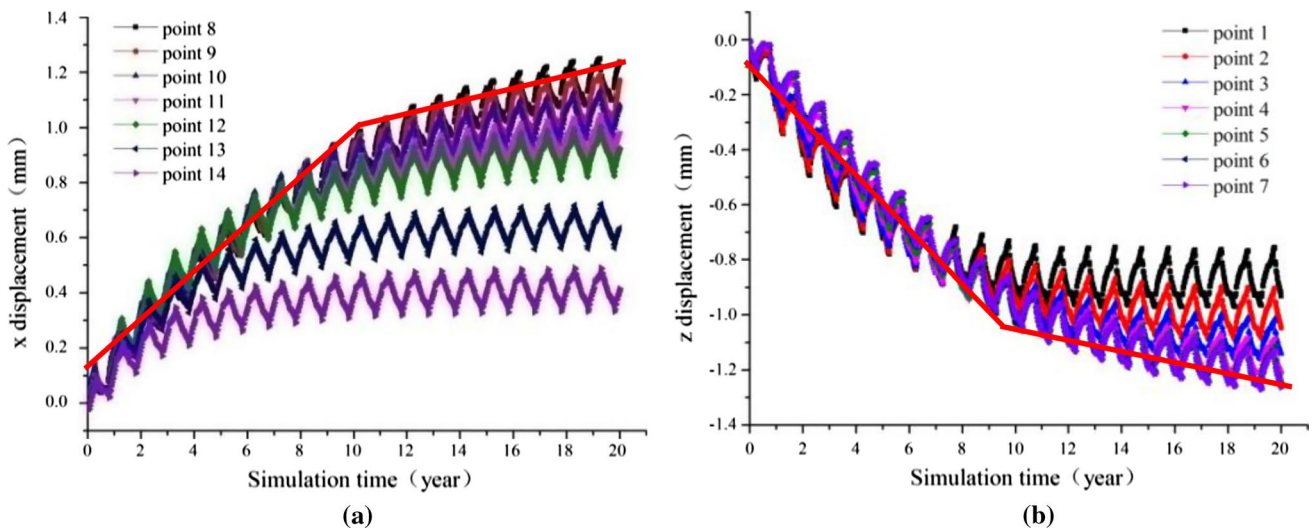
**Fig. 13** Trends of the displacements of the monitoring points under extreme climatic conditions. **a** Horizontal displacement, **b** vertical displacement

Figure 13 shows the deformation trend of all monitoring points under extreme cold weather conditions. In comparison, the maximum displacement in horizontal and vertical directions under extreme weather conditions (1.3 mm) is more than twice as much as the maximum displacement value (0.5 mm) under normal climatic conditions. Figure 13 also shows that the deformation trend over longer periods of time in an extreme climate is comparable to that under a normal climate, which indicates that the wall deformations remain in a controllable range. Thus, the conclusion can be made that the temperature has little impact on the city wall and the damage remains in controllable range.

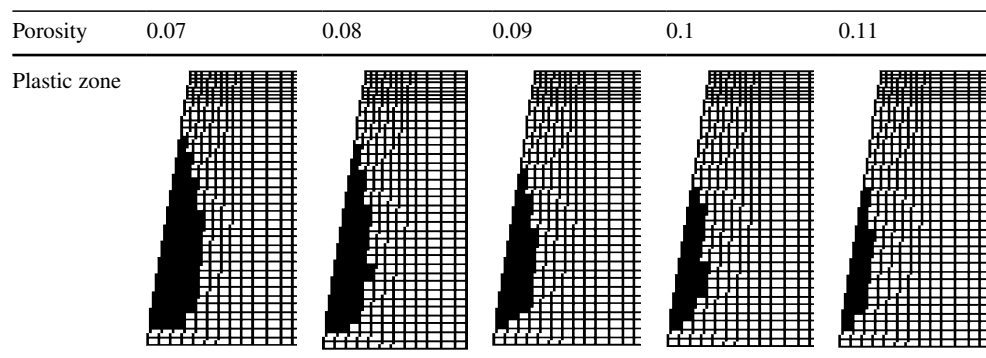
**Table 5** Effect of porosity on the simulation results

For the numerical calculation of the seepage flow, six fluid parameters were used: porosity, permeability coefficient, fluid modulus, fluid tensile strength, fluid density, and saturation. The result of calculation and analysis showed that the porosity was the most significant parameter among these parameters. For a rainfall with intensity of 40 mm/h and duration of 1 day, the effect of porosity on the plastic failure is shown in Table 5.

Table 5 shows that the plastic zone is mainly located at the surface of the city wall. With an increase in the porosity, the plastic zone decreases in thickness. It shows that when the porosity was less than a critical value, the plastic deformation was intensified and the crack expansion phenomenon is more serious. The permeable channels inside the city wall affect the wall stability. When the permeable channels are blocked or partially blocked, the overall porosity of

the whole city wall decreases and plastic failure may occur at the end of the wall due to rainfall, as shown in Table 5. Therefore, the permeable channels of the city wall must be kept clear to discharge the rainwater properly so that the city wall can be prevented from the heavy rainstorms failure.
