Design and performance of a novel multi-function debris flow mitigation system in Wenjia Gully, Sichuan

Keywords Wenjia mitigation system · Debris flow · Early Warning System · Wenchuan Earthquake · Co-seismic landslide

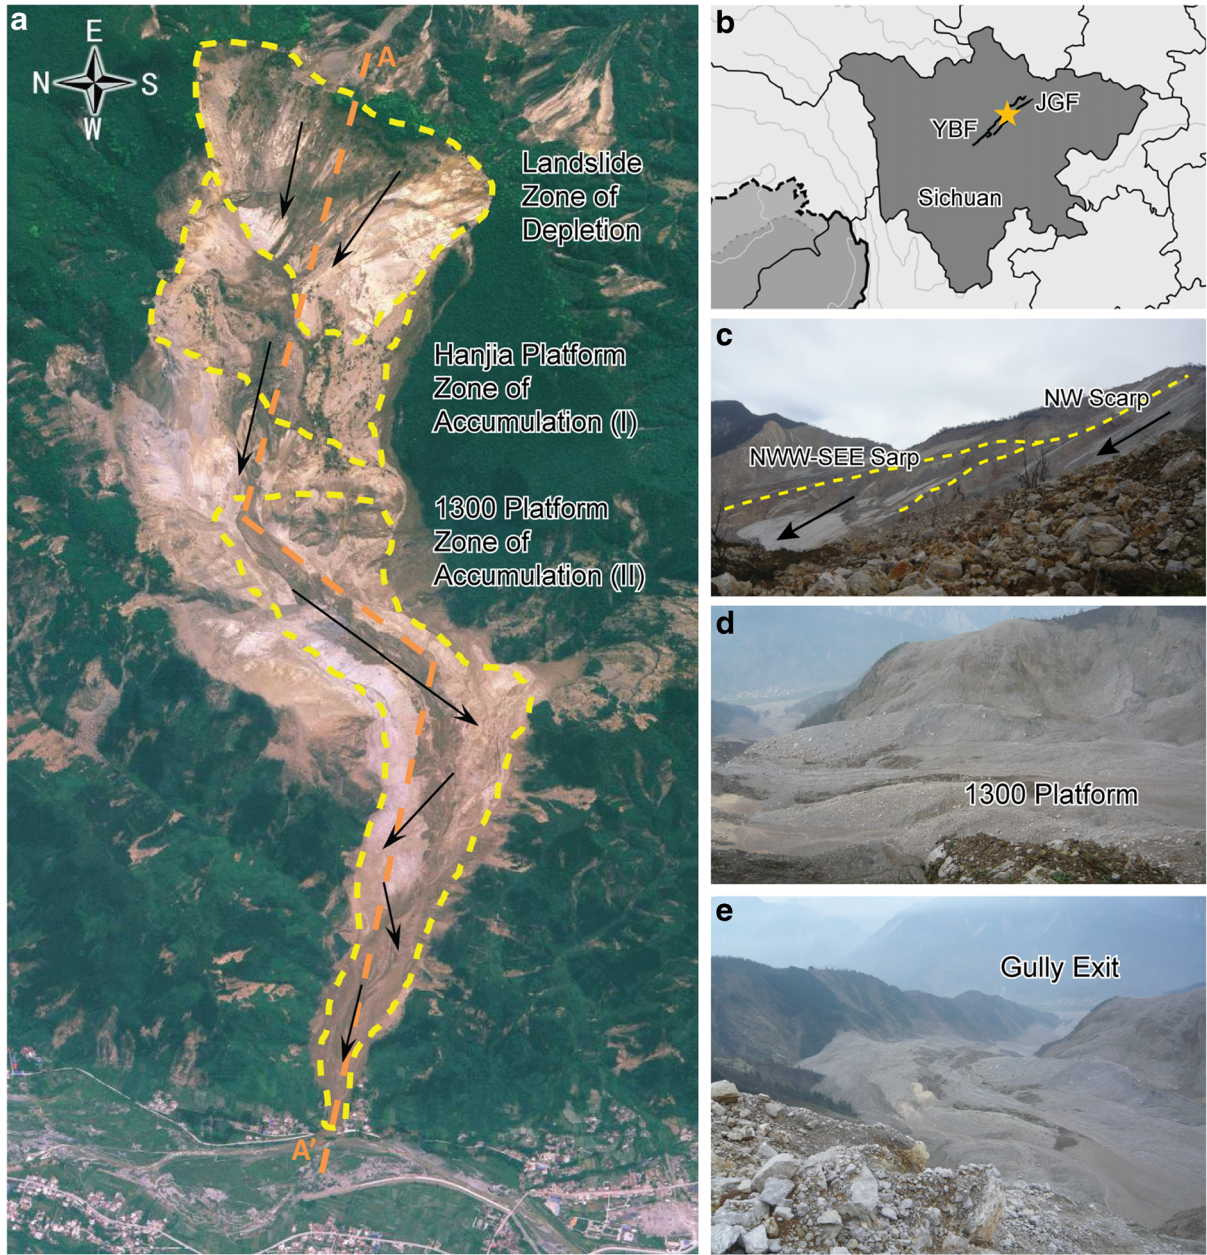
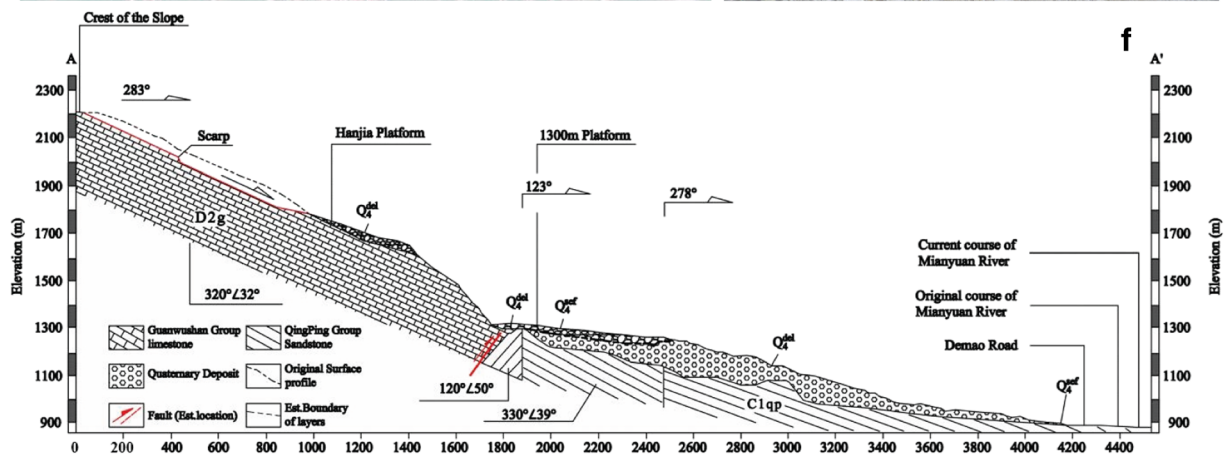
◀ **Fig. 1** The landslide/rock avalanche induced by the 2008 Wenchuan Earthquake. **a** Post-earthquake image of the gully, with the possible landslide moving trajectory (Image: May 23, 2008). **b** Location of the study area. *YBF* Yingxiu-Beichuan Fault, *JGF* Jianguyou-Guanxian Fault. **c** The scarps of the co-seismic landslide. **d** Image of the 1300 m platform. **e** Image of the Zone of Accumulation II. **f** The geological profile of cross section A-A'

The gully is located on the left bank of the Mianyuan River in the Qingping area near Mianzu County in Sichuan (Fig. 1b). It is situated less than 4 km SE of the Yingxiu-Beichuan thrust fault and 80 km NE of the epicenter of the 2008 Wenchuan Earthquake (M_S 8.0). The depth of the gully was 30–50 m with a length of 3 km (highest elev. 2402 m) and an average slope gradient of 45° before the earthquake; it had extensive vegetative coverage with an area exceeding 80% of the basin (Wang et al. 2014). The gully is situated on the Guanwushan Group (Upper Devonian Period) and

The ground shaking caused a deep-seated co-seismic landslide in the gully that initiated at an elevation of 1780–2340 m. Two main scarps were observed orientating WNW-SEE and NW (Fig. 1c); it was postulated that the displaced materials originated from the two adjacent limestone rock blocks. The total volume of the rock blocks was $27.5 \times 10^6 \text{ m}^3$, of which nearly 70% remained on the Hanjia Platform, while the rest entered the 1300 m Platform (a platform at the elevation of 1300 m) as shown in Fig. 1d. The landslide transformed into a rock avalanche and entrained a large amount of shallow sand-gravel materials during its movement (Xu et al. 2009; Xu 2010). The estimated volume of loose deposits in the 1300 m Platform and the Zone of Accumulation II was $30 \times 10^6 \text{ m}^3$ (Fig. 1d, e). Based on the characteristics of the deposits, a hypothetical flow trajectory for the landslide was proposed and delineated as shown in Fig. 1a.

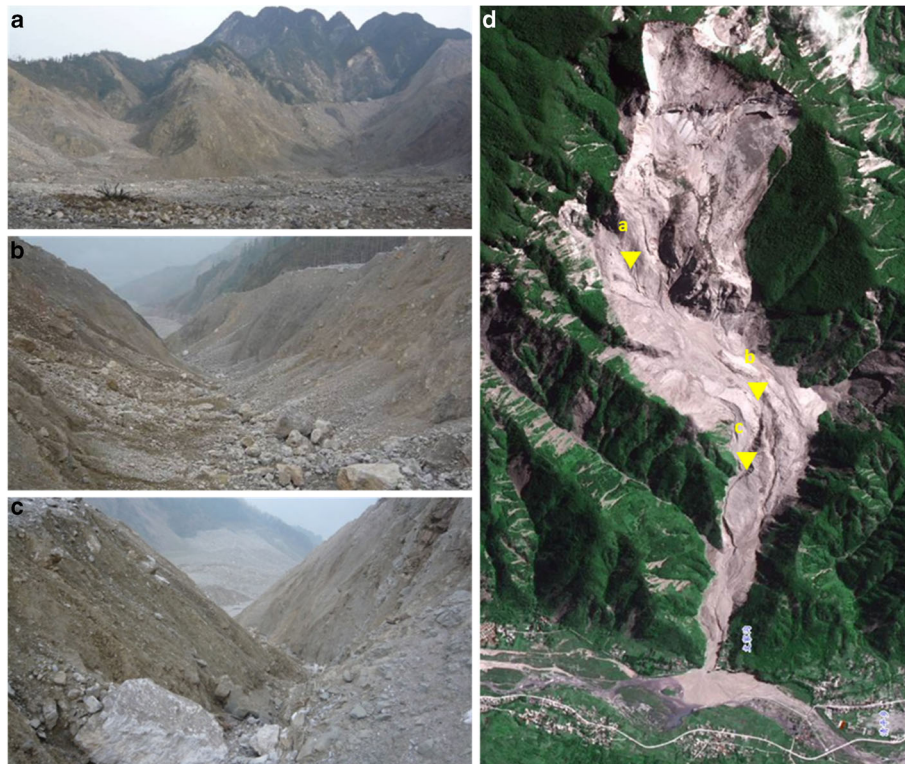
Fig. 2 Images of the Wenjia Gully after the debris flow on September 24, 2008. **a** Loose deposit near the toe of the Hanjia Platform. **b** Channelized erosion in the Zone of Accumulation II. **c** Deep incision due to surface run-off. **d** Post-debris flow image (Image: Oct 13, 2008)

11.5 mm. The intense surface run-off mobilized the loose deposits in the Zone of Accumulation I and II (Fig. 2a), and resulted in channelized erosion and deep incisions (approx. 20 m) in the gully (Fig. 2b, c). The volume of the debris flow was estimated as $0.5 \times 10^6 \text{ m}^3$, which is less than 1% of the loose deposit in the gully (Xu et al. 2009), but it destroyed the infrastructure near the outlet of the gully and part of the Qingping area. The deposit from the debris flow formed a dam and resulted in water impoundment in the Mianyuan River.

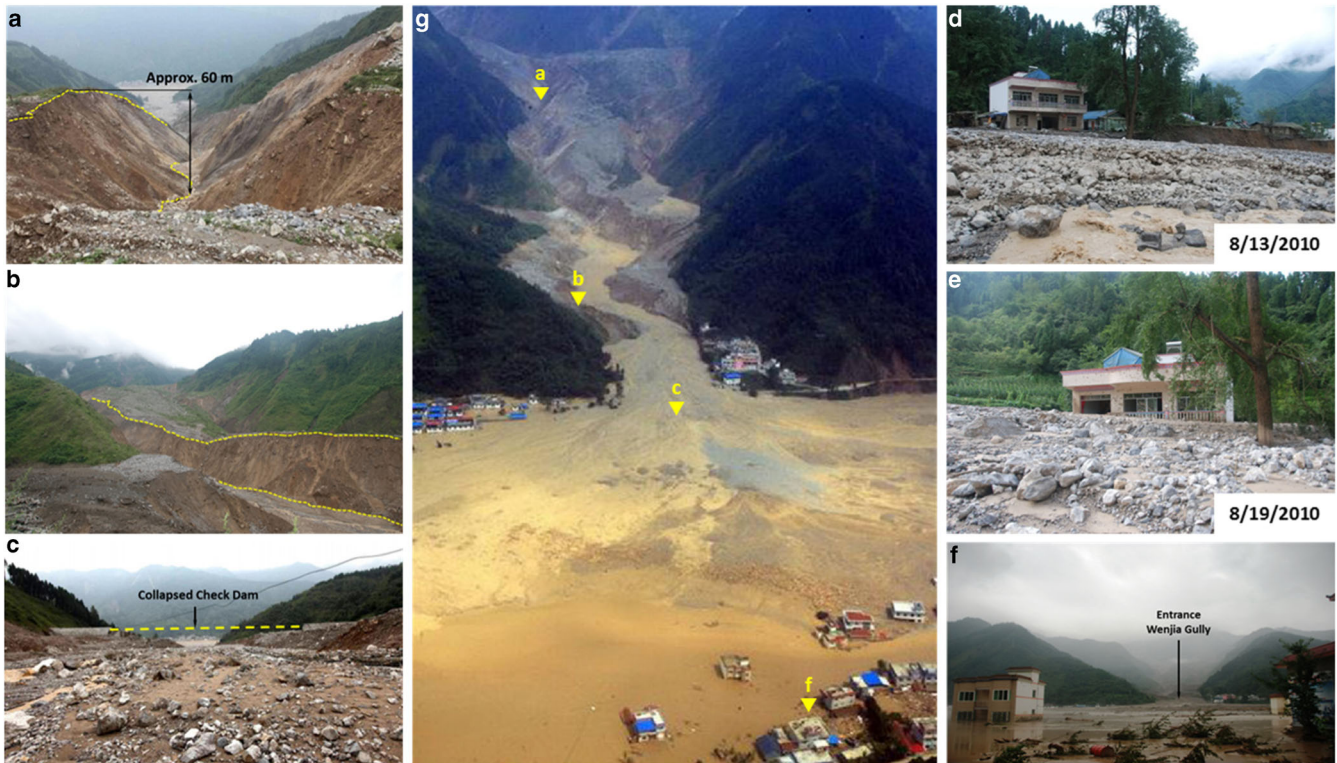
Fig. 3 The devastating debris flow occurred on August 13, 2010. **a** Deep incision due to channelized erosion on the 1300 m Platform. **b** Widened debris flow channel near the outlet of the gully. **c** Failure of the last check dam (after Tang et al. 2012). **d** A buried house in Qingping Village (August 13, 2010). **e** Increase in the thickness of the deposit after a subsequent debris flow (August 19, 2010). **f** Submerged area near the outlet of the gully. **g** Aerial image of the debris flow with approximated locations of the images presented herein

interrupted the rapid-response construction of mitigation measures and deposited an additional $17.6 \times 10^4 \text{ m}^3$ of sediment (Fig. 3d, e).

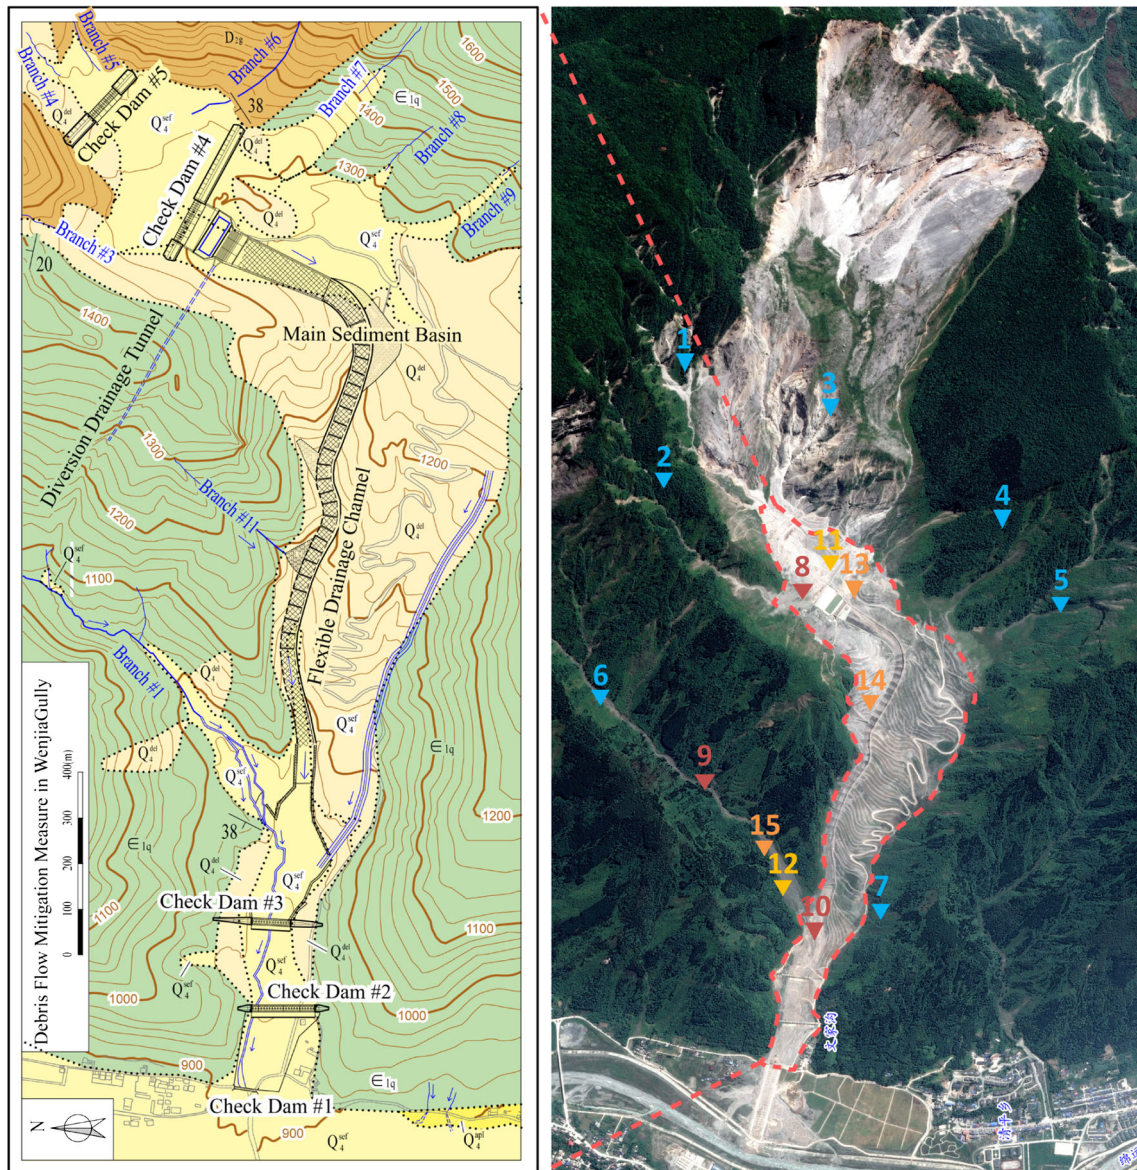
Fig. 4 The debris flow mitigation system in the Wenjia Gully. Check Dams #4 and #5 are located upstream between the Hanjia Platform and 1300 m Platform. The midstream section consists of a flexible drainage channel. Three check dams were constructed in the downstream of the gully. A large number and variety of sensors were installed in the gully and/or its catchment, including the rain gauges (1–7), thickness gauges (8–10), piezometers (11–12), and video cameras (13–15)

The debris flow mitigation system has a designed seismic resistance of VII on the Mercalli Intensity scale and was completed in May 2011 (Fig. 4). Reflecting the proposed design, the system has three key sub-systems: (1) a combined sediment basin and debris flow breaker with a drainage tunnel in the upstream section of the gully, (2) a flexible drainage channel in the mid-region of the gully to “guide” the movement of debris flows, and (3) five check dams in the upstream and downstream sections of the gully. A service road was excavated parallel to the flexible drainage channel to allow access by equipment for periodic emptying and maintenance of the debris basins. Part of the Zone of Accumulation II was excavated for the construction of the drainage channel.

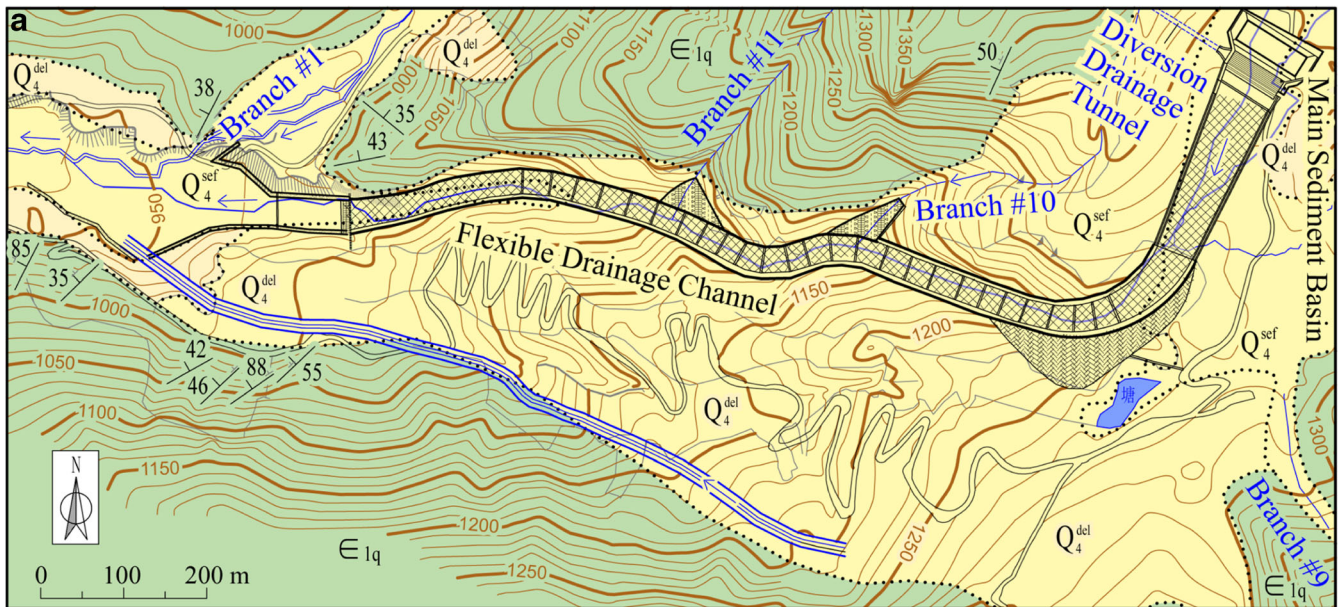
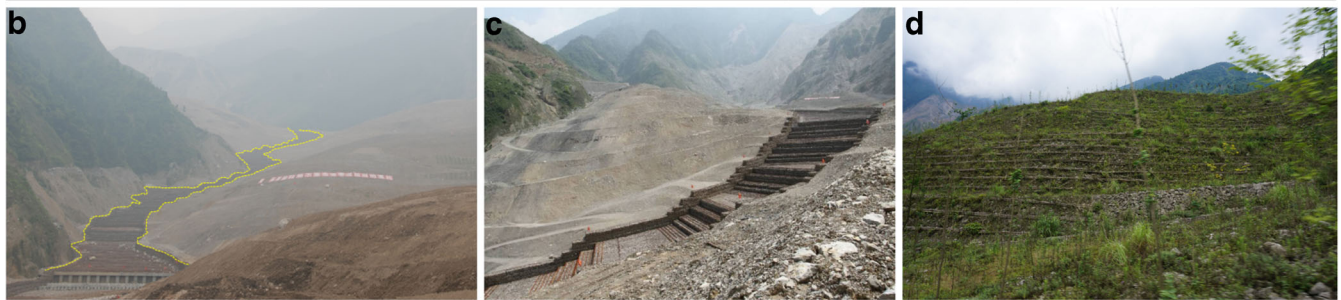
Fig. 6 The mitigation measures in the midstream section of the Wenjia Gully. **a** A plan view of the mitigation structures. **b** An overview of the flexible drainage channel. **c** A close view on the stepped channel on the 1300 m platform. **d** Terraced loose deposits on the south of the channel with ground seeding and LEBs for stabilization

The mitigation structure in the mid-region of the gully is a stepped flexible drainage channel extending from the debris flow breaker system to the outlet of the gully (Fig. 6a). The channel has a total length of 1290 m containing 25 steps at an average interval of 27 m with widths ranging from 45 m (upstream end) to 30 m (downstream end); it aims to reduce the volume of debris flow by minimizing erosion using gabion basket modules (Fig. 6b). The gabion modules buttress riprap that consists of angular and resistant rocks, which deforms under the impact of a debris flow without significant reduction of its efficiency (Costa and Wiczorek 1987). The stepped chute promotes kinematic energy dissipation, which drastically decreases the discharge rate of the debris flow, and in turn, the impact to the midstream and downstream of the gully by minimizing the energy (i.e. discharge control) and reducing the volume of the debris flow (i.e. erosion control).

The upstream end of the channel is connected to the water-sediment segregation system, and a pile system (23 piles) was installed at the downstream end (Fig. 6b). Retaining structures were constructed on both sides of the channel (Fig. 6b, c). A service road was excavated on the hillslope located to the south of the channel, where a large amount of sediment was deposited due to construction of the channel.

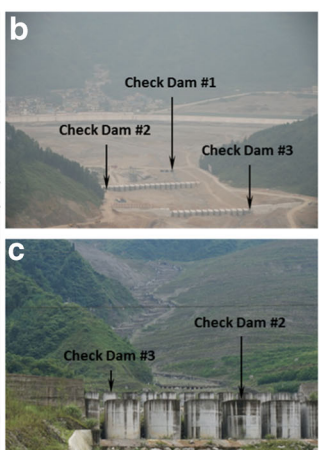
Fig. 7 The mitigation measures in the downstream section of the Wenjia Gully. **a** A plan view of Check Dam #1 (for pedestrian assess), #2, and #3 and the debris basins. **b** An overview of the check dams on near the exit of the gully. **c** A close view on the concrete fins of Check Dam #2 (image taken from Check Dam #1)

The mitigation system in the downstream section of the channel focuses on intercepting the medium and large boulders and rock masses from Branches #1 and #2 as well as any possible far-reaching sediments that originate from the upstream (Fig. 7a).

The main structures consist of three check dams with sectional barriers and concrete fins (Fig. 7b, c). Check Dam #2 has a height of 6 m above ground level with a design width for overflow of 139 m and a maximum volume of $67.5 \times 10^3 \text{ m}^3$ for the debris basin. Check Dam #3 has a height of 5 m with a design capacity of the

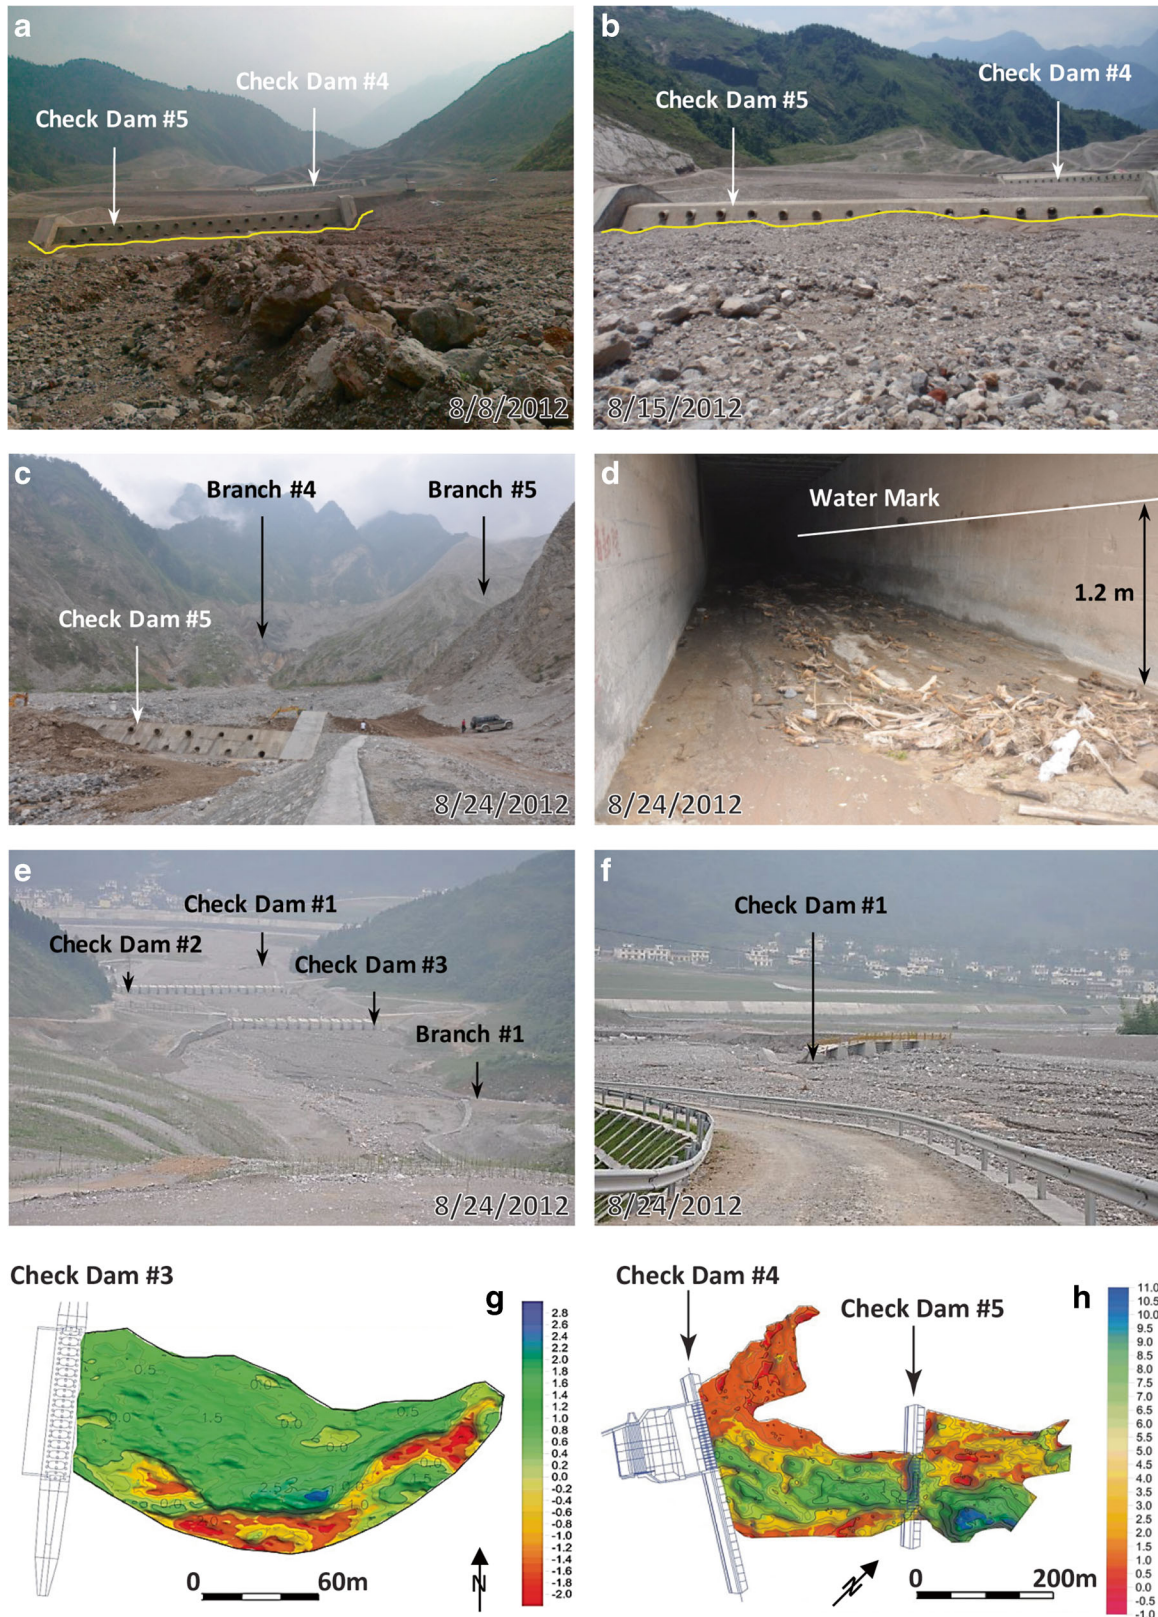
Fig. 9 The pre-/post-debris flow images in the monsoon season of 2012 and the elevation difference in the debris basin between August 2012 and July 2013. **a** Surface profile of the deposit in the basins. **b** Surface profile of the deposit after the debris flow on August 14 showing change in the thickness of the basin. **c** Overtopping of Check Dam #5 due to the debris flow on August 17. **d** Water level in the drainage tunnel. **e** Deposit in the debris basins of Check Dam #2 and #3 after the debris flow on August 17. **f** Damaged Dam #1 due to the erosion by the debris flow initiated in Branch #1. **g** Debris basin variations in Check Dam #3 showing evident scouring in the deposit on the south side of the basin. **h** Debris basin variations in Check Dam #4 and #5 showing surface erosion caused by loose deposits mainly from Branch #3

In 2013, rainstorms were reported in the gully on June 18–20, June 29, July 1, July 3–5, and July 7–11 ($R_d = 836.5 \text{ mm}$; $I_{max} = 71 \text{ mm/h}$). Many of the monitoring instruments were defective due to inadequate maintenance. Field data is summarized and shown in Fig. 8c, but the exact time of the occurrence of the debris flow cannot be determined. Interviews with local residents confirmed that the debris flow occurred at 22:00–23:00 on July 8. The loose deposits in Branches #4 and #5 provided the source material, with significant incision and undercutting in both branches. The debris flow reached the debris basin of Check Dam #4 and damaged the left flank of the dam. A considerable amount of water entered the drainage tunnel causing minor erosion in Branch #1, which in turn mobilized and deposited some sediments in the debris basin of Check Dam #3. The total volume of the debris flow was estimated as $344,000 \text{ m}^3$ based on the changes of the thickness of deposit in the debris basins (Fig. 9g, h).

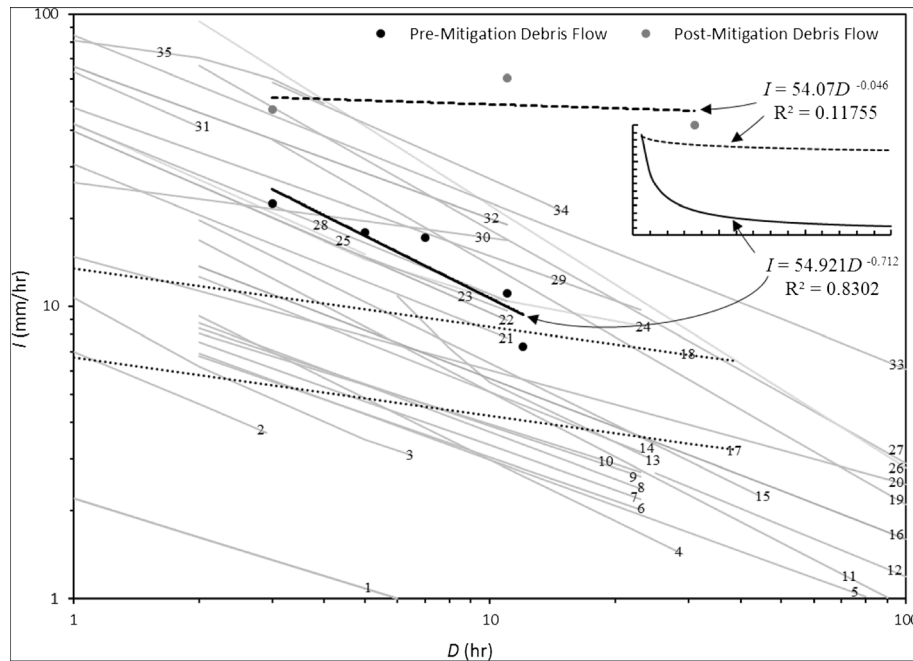
Fig. 11 Mean rainfall I - D thresholds for pre-/post-mitigation debris flows in the Wenjia Gully and other global and regional thresholds proposed in the previous research (references see Table 2). The poor correlation in the post-mitigation I - D threshold can be attributed to the limited data. A sharp escalation in the I - D threshold can be observed after implementing the mitigation system

The mean rainfall intensity-duration (I - D) thresholds are used to further evaluate the performance of the system. The pre-mitigation I - D thresholds were established from the five debris flows occurred before implementation of the system ($I = 54.921D^{-0.712}$), and the three events occurring afterwards were used to establish the post-mitigation I - D thresholds ($I = 54.07D^{-0.046}$).

The mean rainfall intensity decreases linearly as rainfall duration increases on a log-scale before the mitigation system; however, it remains almost unchanged with an increasing duration in the post-mitigation scenario (Fig. 11). The pre-mitigation I - D threshold for the Wenjia Gully is higher than many of the proposed global and regional thresholds, but the post-mitigation I - D threshold is considerably higher than any of the proposed values in Table 2, indicating a drastic change in the I - D curves due to the mitigation system. Decreases in the regional I - D thresholds are typical after a strong earthquake, but changes in the pre-/post-mitigation thresholds of a debris flow site are rarely assessed. In the pre-/post-mitigation rainfall I - D curves on a linear scale (Fig. 11), rainfall duration shows little correlation with debris flow occurrences after implementation of the system, which implies that loose deposits are more prone to debris flow under intense surface run-off but less affected by the pore water conditions.

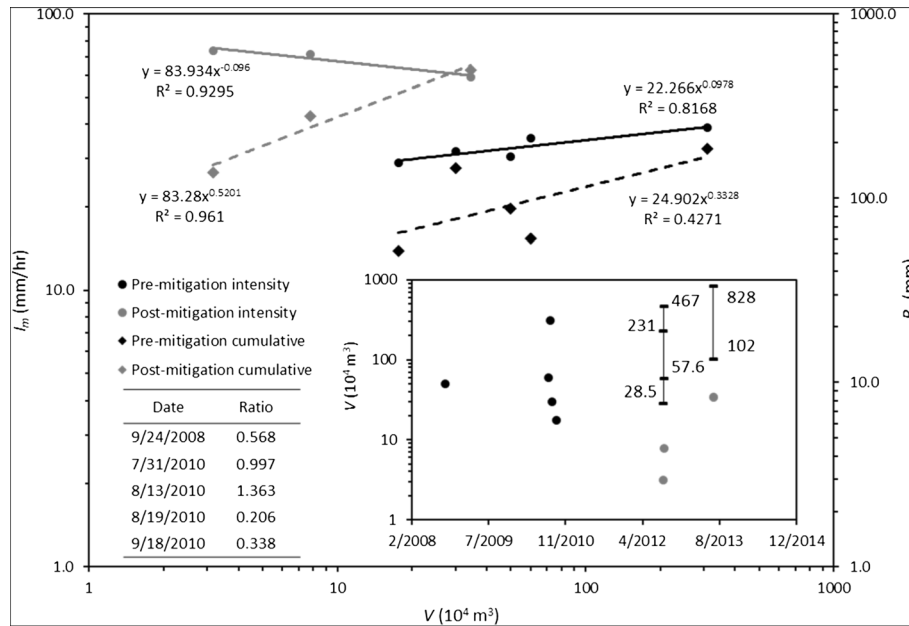
Fig. 12 Empirical correlations between I_m , R_d and V before and after implementing the mitigation system. Strong correlations are shown for the post-mitigation cases, with significant changes in the pre-/post-mitigation correlations, which indicate modifications on the characteristics of the rainfall-induced debris flows due to the mitigation system. Ratios between R_d and pre-mitigation V are used to estimate the V_{max} and V_{min} of the potential debris flows, assuming no mitigation system. Comparison of V and the estimations shows substantial differences

The empirical relations between I_{max} , R_{cb} and debris flow volume, V , are presented in Fig. 12. Strong correlations are found between I_{max} and post-mitigation V as well as R_{cb} and post-mitigation V , which are noticeably higher than that of the pre-mitigation cases. As presented in Fig. 12, the ratios between R and pre-mitigation V can be used for a simplified extreme value analysis which estimates a maximum and minimum V for an observed R_{cb} assuming the absence of the mitigation system, and such estimations are substantially higher than the observed values. For the case of the debris flow that occurred on July 8, 2013, the estimated volume ranges 8×10^6 – 1×10^6 m³ (27 to 3 times greater than that
