# Classification of large-scale landslides induced by the 2008 Wenchuan earthquake, China

**Abstract** Over 30,000 landslides were triggered by the 2008 Wenchuan earthquake. The deformation and failure mechanisms of these landslides have been found distinct from those of general landslides self-weight induced. Under gravity, typical sliding in rock slope commonly occurs along a gentle tension crack in some depth at the rear part, which connects to a shear plane at the lower part of the slope to form a complete failure surface. However, due to seismic shaking, a much deeper and steeper tension crack tends to develop at the rear part, which promotes the shearing at the far lower part of the slope. In this paper, the failure modes of earthquake-induced landslides have been classified into four scenarios, in terms of failure mechanisms, characteristics of geological structures, and development of the sliding surface, i.e., tension-strike slipping, tension-dip layering, tension-shattering, and tension-shearing failures. This is evidenced by field investigations. Detailed field investigations were performed on the deformation and failure characteristics of large-scale and deep-seated la

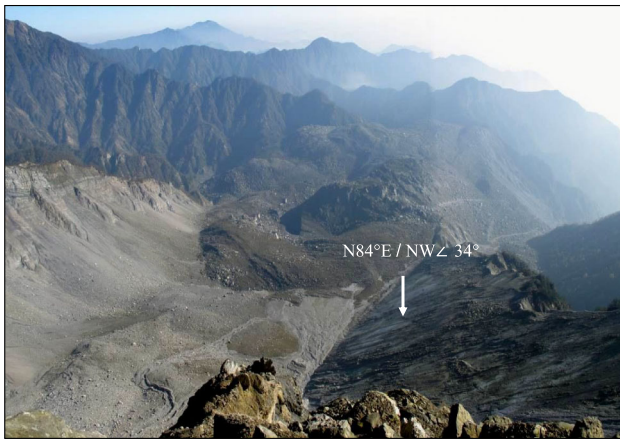
**Fig. 4** Aerial view of the Daguangbao landslide (sliding direction of NE, Huang et al. 2012a, b)

The Daguangbao landslide is a typical event with the mode of tension-strike failure in the Wenchuan earthquake area (Fig. 4). The Daguangbao landslide is located in Gaochun, Anxian County (Fig. 1) and is the largest landslide triggered by the Wenchuan earthquake, with a volume of approximately 712 million m<sup>3</sup> (Huang et al. 2008; Huang 2012). As shown in Fig. 4, the source material of Daguangbao landslide is mainly composed of highly weathered argillaceous limestone of Sinian (Z<sub>4</sub>), with partial phosphate and associated minerals formed in Devonian (D<sub>3</sub>). The covering area of the depositional material is measured as 7.12 km<sup>2</sup>. The travel distance of runout materials is 4500 m with an elevation difference of 1500 m (Table 1). When the landslide happened, the runout debris struck two buildings located within the deposition zone, caused 38 deaths, blocked the river, and formed a debris dam.

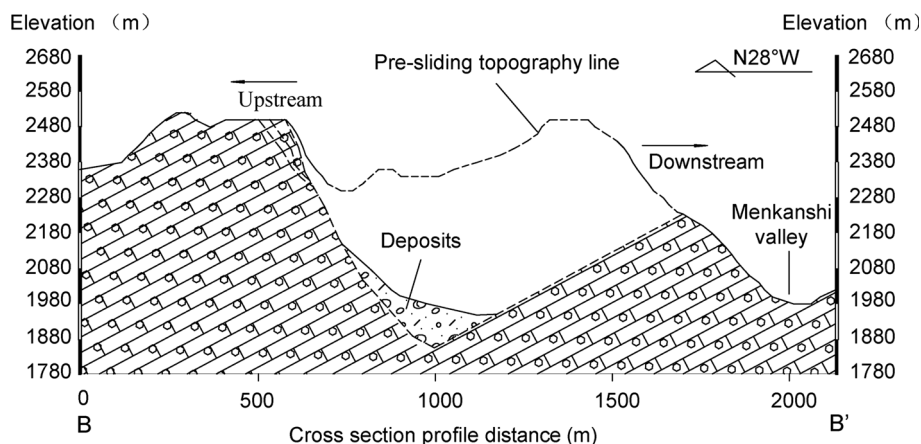
**Fig. 6** Cross section (B-B') showing source area of the Daguangbao landslide (Huang et al. 2012a, b)

The rock layer of the Daguangbao landslide strikes at N80–88°E and dips at NW with dip angle of 34°–38°. As shown in Figs. 5 and 6, the slope is dipping at the same direction as the rock layer's strike. The SE side of the mountain ridge is steep, caused by the cutting of Menkanshi Gully. Contours of two sets of well-developed joints (N40°W/NE∠80°–85° and N55–60°E/SE∠60°) are parallel to the strike and dip direction, respectively (Fig. 5). The two sets of joints together with the free surfaces at E and S sides tend to divide the rock mass into

blocks (Huang et al. 2012a, b). Based on the slickenside at the slip surface, it can be speculated that the sliding mass cannot completely slid along the strike direction since the rock layer is dip to inner-slope. As shown in Fig. 5, a cross-angle can be observed between the sliding and strike direction at the initial stage of the slope failure. However, the sliding deformation along this direction can be blocked by the mountain nearby, and the sliding mass had to gradually shift to the other direction in order to slide out smoothly (Fig. 5). Under earthquake shaking, the sliding mass was detached, along the NW joints, from the trailing edge, and slid along the NE joints and the bedding plane beneath (Fig. 6).

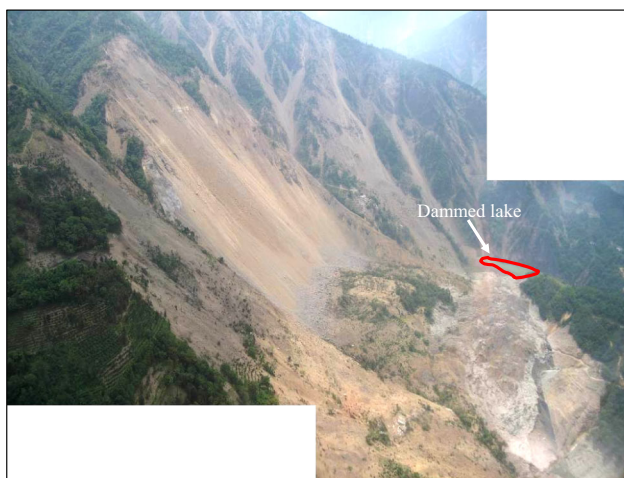
**Fig. 7** Overview of the Tangjiashan landslide in Beichuan

The Tangjiashan landslide triggered by the Wenchuan earthquake was located in Beichuan County, which is typical of high-speed tension-dip failure with sliding velocity of 30 m/s (Fig. 7). Before the earthquake, the average slope gradient of Tangjiashan landslide is 40°, elevation of the slope ranges from 665 to 1500 m, with a relative relief of 835 m. The covering area of this landslide is estimated as 0.57 km<sup>2</sup>. The Tangjiashan landslide originated in weathered metamorphic slate, sandstone, and pelite. The sliding surface of this landslide was identified along the bedding planes. A volume of 20.37 million m<sup>3</sup> formed a blockage of 803 m in length along the channel, 611 m in width across the channel, and 83–124 m in thickness (Cui et al. 2012). Since the travel distance of the landslide is approximately 1020 m and the duration of sliding is around 30 s (according to the eyewitness’s description), the sliding velocity was estimated as 30 m/s (Table 1). A 20 million m<sup>3</sup> landslide dam formed in the Jian River with length of 803.4 m, width of 611.8 m, and thickness of 124 m. As shown in Fig. 7, the capacity of the landslide lake was 300 million m<sup>3</sup> (Hu et al. 2009). Approximately 100 people were killed during this disaster.

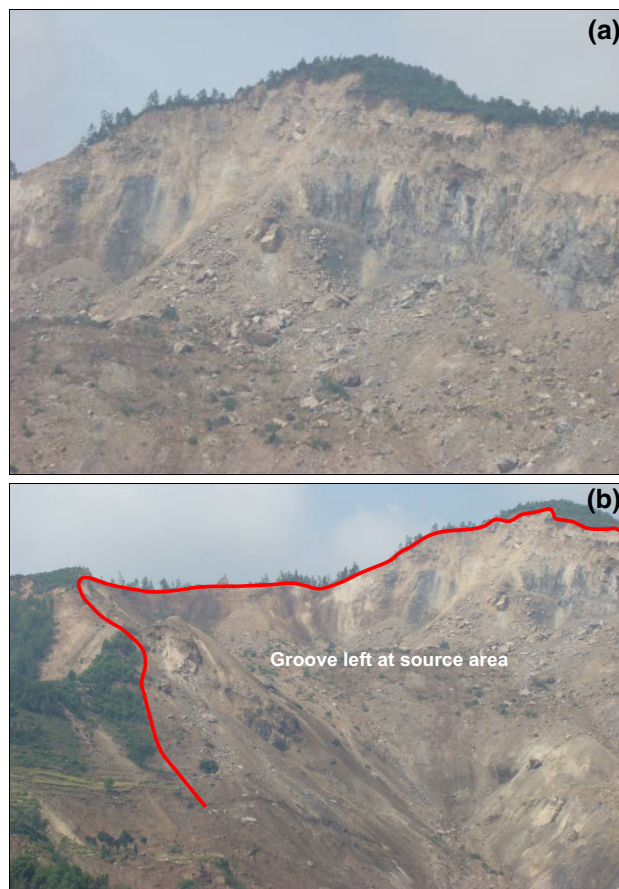
**Fig. 8** Donghekou landslide in Qingchuan: **a** steep scarp, **b** a huge groove left at the source area

Another typical representative is the Donghekou landslide (Fig. 8). The Donghekou landslide is triggered by the Wenchuan earthquake, occurred in Donghekou Village, Qingchuan Country, Sichuan, with a distance of approximately 3 km to the north of the Yingxiu-Beichuan-Qingchuan fault (Fig. 1). The source materials are mainly composed of dolomitic limestone, dark gray siliceous shale, and carbonaceous quartz phyllite. The landslide dammed two confluent rivers (i.e., the Qingzhu River and the Hongshi River) and formed a massive landslide lake. When the landslide occurred, the debris of the landslide inundated four villages and a bus station, two large tourist buses, one car, and 780 villagers were buried. This typical

Donghekou landslide is characterized by a typical sandwich structure, as shown in Fig. 9, and the rock layer of Cambrian overlies the Sinian due to the total formation overturned. Tensile structure surfaces are widely distributed, especially concentrated at the rear and lateral parts of the slope. The rock layer of Donghekou landslide is gently inclined outwards at a dip angle of about 12°. A steep pull-apart plane appeared at the trailing edge under a strong horizontal seismic load. Afterwards, the rock mass slid along the weak plane beneath, and a large groove was left in the source area as shown in Fig. 8b.

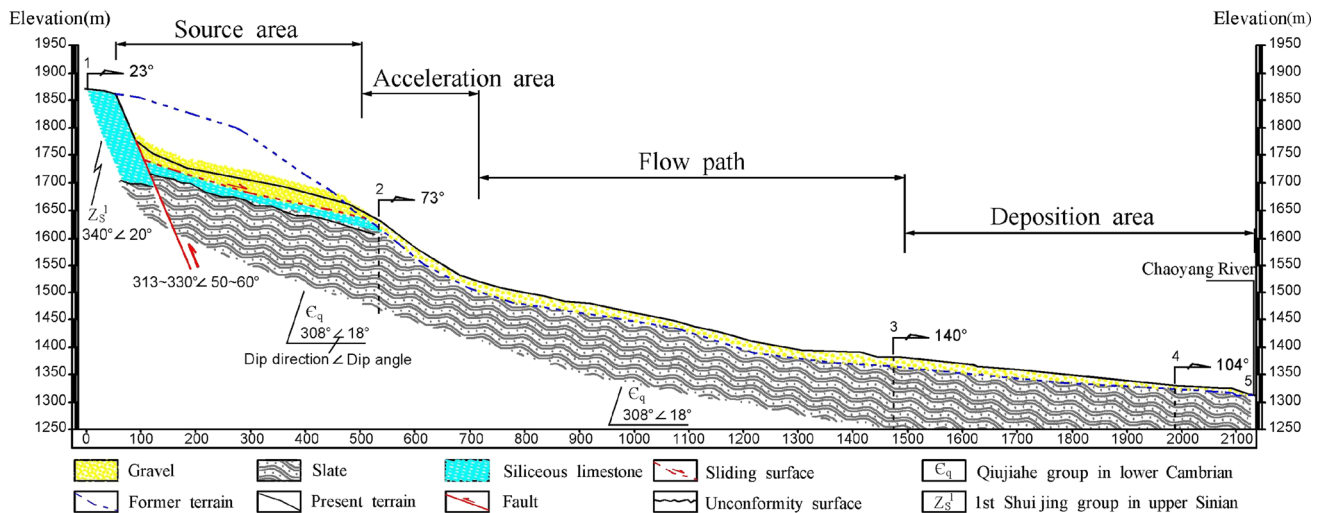
**Fig. 9** Cross section of the Donghekou landslide in Qingchuan

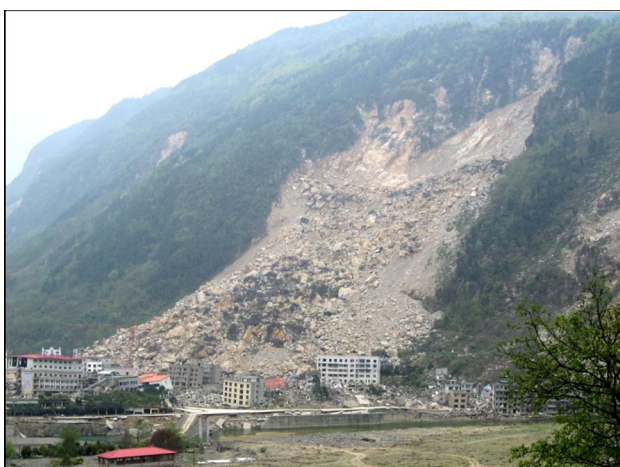
**Fig. 10** Overview of the Beichuan New Middle School landslide

A representative of tension-shattering failure is the Beichuan New Middle School landslide (Fig. 10). The Beichuan New Middle School landslide is an ancient landslide with a covering area of 0.12 km<sup>2</sup> (Table 1). The volume of the deposition material is approximately 2.4 million m<sup>3</sup> with an average thickness of 20 m. This landslide was mainly composed of blocks and stones. The travel distance of the runout debris was estimated as 500 m with an elevation difference of 450 m. When the landslide happened, the impulsive force totally destroyed a three-

storied building in the New Middle School and took the lives of nearly 500 people (see Fig. 10).

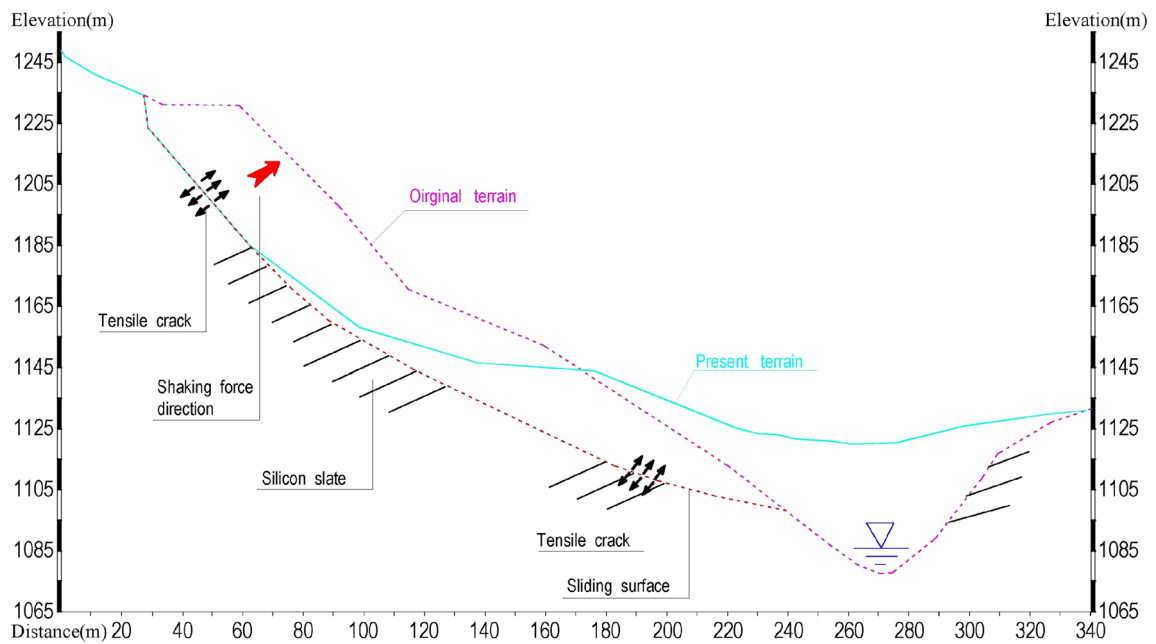
**Fig. 13** Longitudinal section and failure mode of the Zhengjiashan 2# landslide

Figure 13 shows the longitudinal section of the Zhengjiashan 2<sup>#</sup> landslide, which illustrates the tension-shearing failure mode. It is worth noting that the failure surface of a tension-shearing failure is completed caused through shearing the rock at the lower part, while the failure plane in other failure modes mentioned above is basically developed by tracking/connecting the existing structure planes/joints. This somehow delays the
