Landslides (2021) 18:2907–2921
 DOI 10.1007/s10346-021-01701-w
 Received: 23 January 2021
 Accepted: 13 May 2021
 Published online: 21 May 2021
 © Springer-Verlag GmbH Germany
 part of Springer Nature 2021

Catastrophic landslide triggered by persistent rainfall in Sichuan, China: August 21, 2020, Zhonghaicun landslide

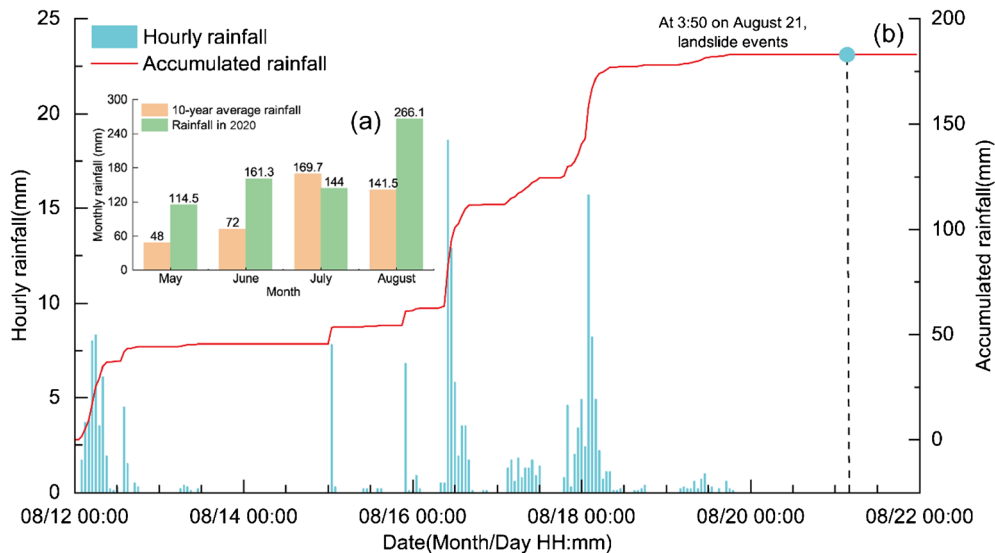
Fig. 3 Daily rainfall and monthly cumulative rainfall recorded by rain gauges near the Zhonghaicun landslide

Affected by the monsoon climate, the temporal distribution of annual rainfall is uneven, and the rainfall from May to October accounts for 81.2% of the annual rainfall. Over the past 10 years, the average monthly rainfall shows that the rainfall is usually the highest in July. As shown in Fig. 3, since August 2020, the study area has suffered from continuous heavy rainfall, with a cumulative precipitation of 266.1 mm, which is more than the monthly cumulative rainfall in the rainy season in previous years. Interviews of residents showed that there was no rainfall in the landslide area during the 2 days before the landslide occurred (i.e., on the 19th and 20th), but several tension cracks were found in the landslide area. Finally, the landslide lagged behind the rainfall and began to slide in the early morning of August 21.

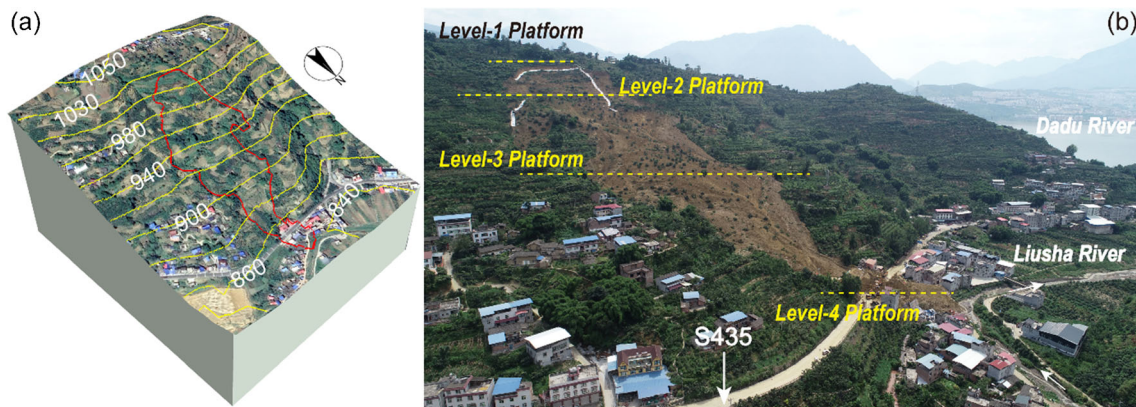
The landslide is located in low- to middle-elevation mountains with a slope dipping north at an average angle of 16°. Four levels of gentle slope platforms are developed in the landslide area, forming topography with alternating steep and gentle slopes (Fig. 4). The highest elevation of the landslide source area is approximately 1030 m, and the landslide toe is located on the left bank of the Liusha River, at approximately 850 m, with a relative height difference of 180 m. All these features provide favorable geomorphic conditions for slope instability.

Fig. 4 Three-dimensional topographic maps of the landslide area

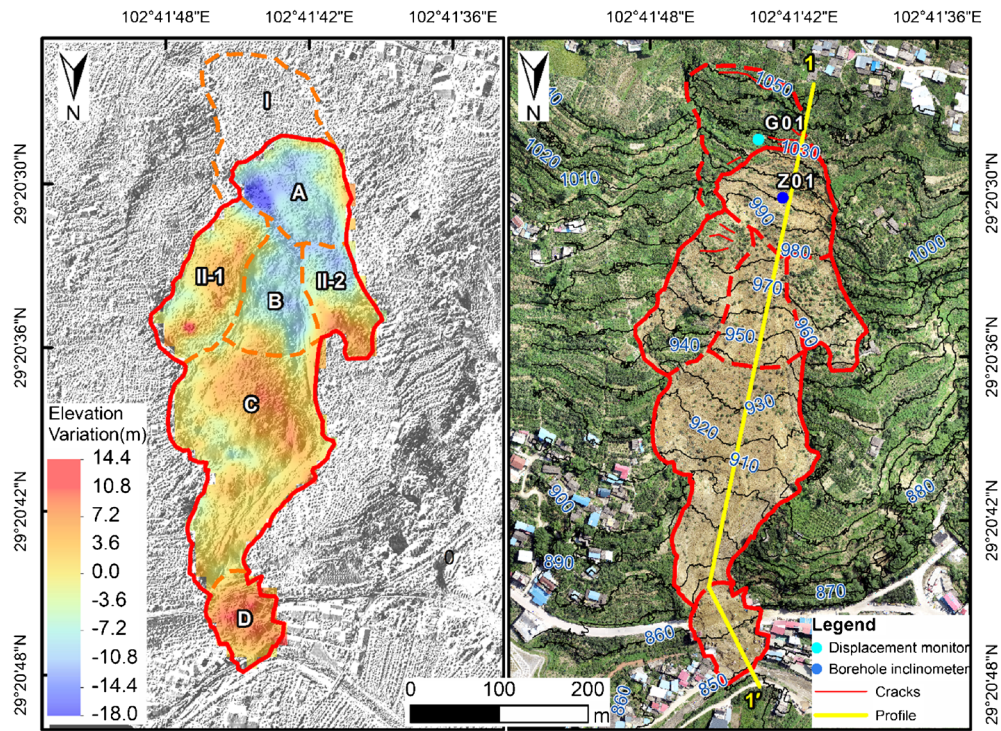
After the landslide, an inclinometer was installed in the Z01 drill hole in the source area (Figs. 6b and 7a). The displacement data show that a new sliding surface is gradually formed at 9.5 m,

Fig. 6 Post-landslide topography: **a** post-landslide digital surface model (DSM) and elevation difference; **b** post-landslide DOM. In (a), A–D mark the zone of major sliding, I–II are different areas affected by instabilities; the displacement monitor and borehole inclinometer arrangement post-landslide are shown in (b)

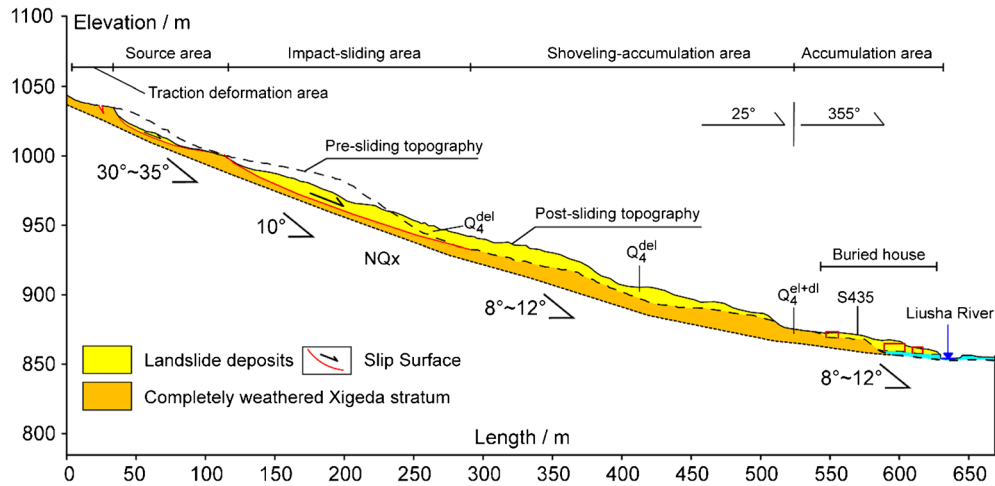
The geological profile 1-1' after the landslide was drawn through field investigation, aerial image interpretation, and geological analysis, as shown in Fig. 14.

Fig. 14 Post-landslide longitudinal profile 1-1' in Fig. 6b

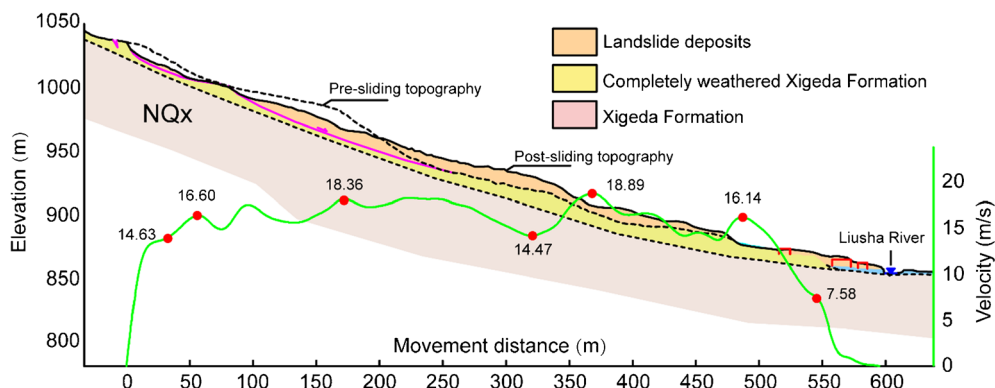
Fig. 16 Estimation velocity of the Zhonghaicun landslide from the 1-1' profile in Fig. 6b

The variation in the microrelief in the landslide area will affect the movement speed of the landslide. Figure 16 shows the velocity of the landslide throughout the process of starting, moving, and finally stopping by using the formula proposed by Scheidegger (1973) based on the principle of energy conversion. The results reveal that the velocity of the sliding mass increases rapidly under the action of substantial potential energy when the sliding mass in the source area starts to lose its stability; the velocity of the sliding mass reaches 16.60 m/s soon after sliding out of the rupture surface. Subsequently, as the elevation decreases, the potential energy is transformed into kinetic energy, the velocity increases, and the maximum speed is 18.89 m/s. Then, as the terrain gradually becomes less steep, the debris flow velocity begins to decline sharply until the front of the landslide is finally stopped by the left bank of the Liusha River. The calculation results show that the whole process of landslide movement from the onset to finally stopping lasts for 68 s, and the average speed of the sliding mass during the whole process is as high as 14.3 m/s.
